**ARCTIC
RESPONSE
TECHNOLOGY**
OIL SPILL PREPAREDNESS

January 20, 2016

S. Potter, I. Buist, D. Cooper - SL Ross Environmental Research Limited
W. Schnabel, J. Garron, R. Perkins, S. Aggarwal, R. Bullock -
University of Alaska Fairbanks
P. Lane - DESMI

FIELD RESEARCH ON HELICOPTER APPLICATION OF CHEMICAL HERDERS TO ADVANCE IN-SITU BURNING

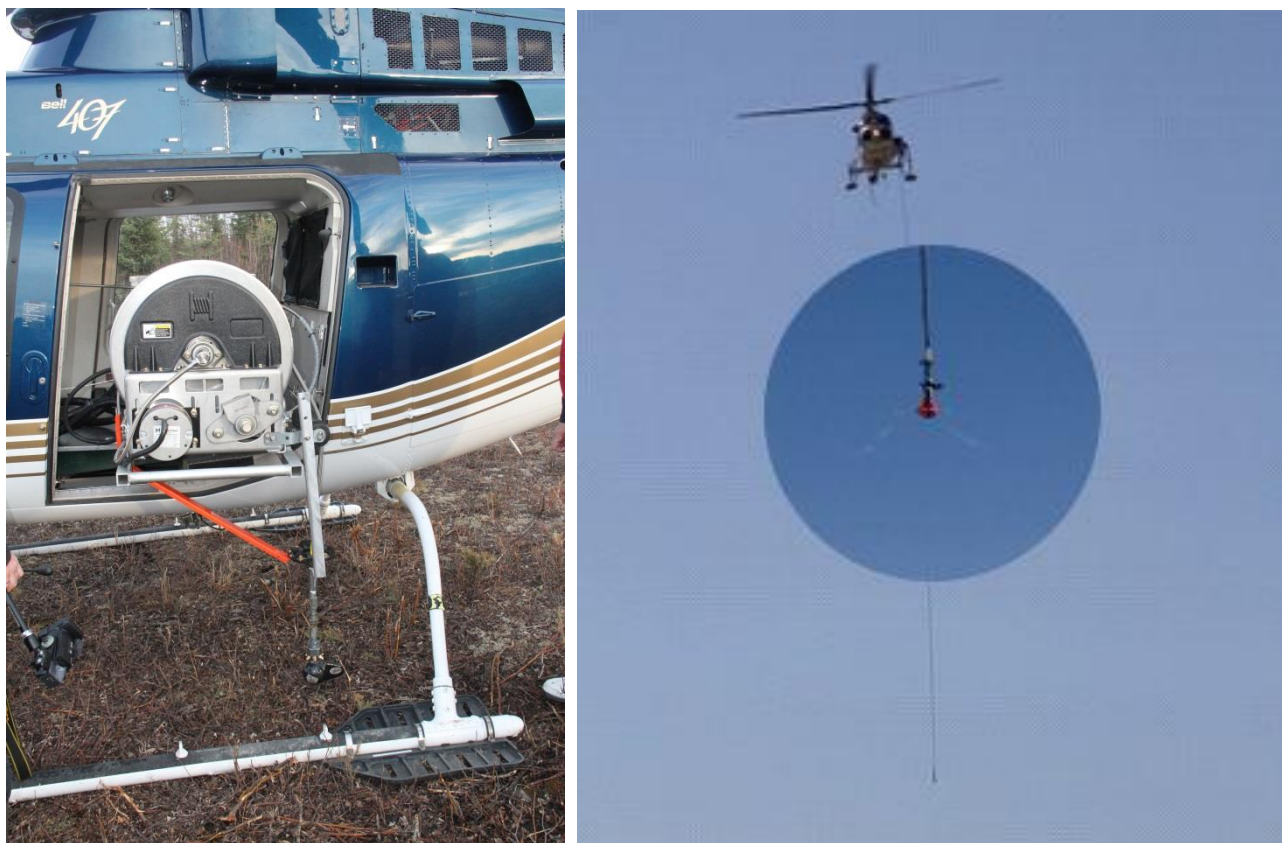
Figure ES-2: Herder application system mounted in Bell 407 and operating over basin

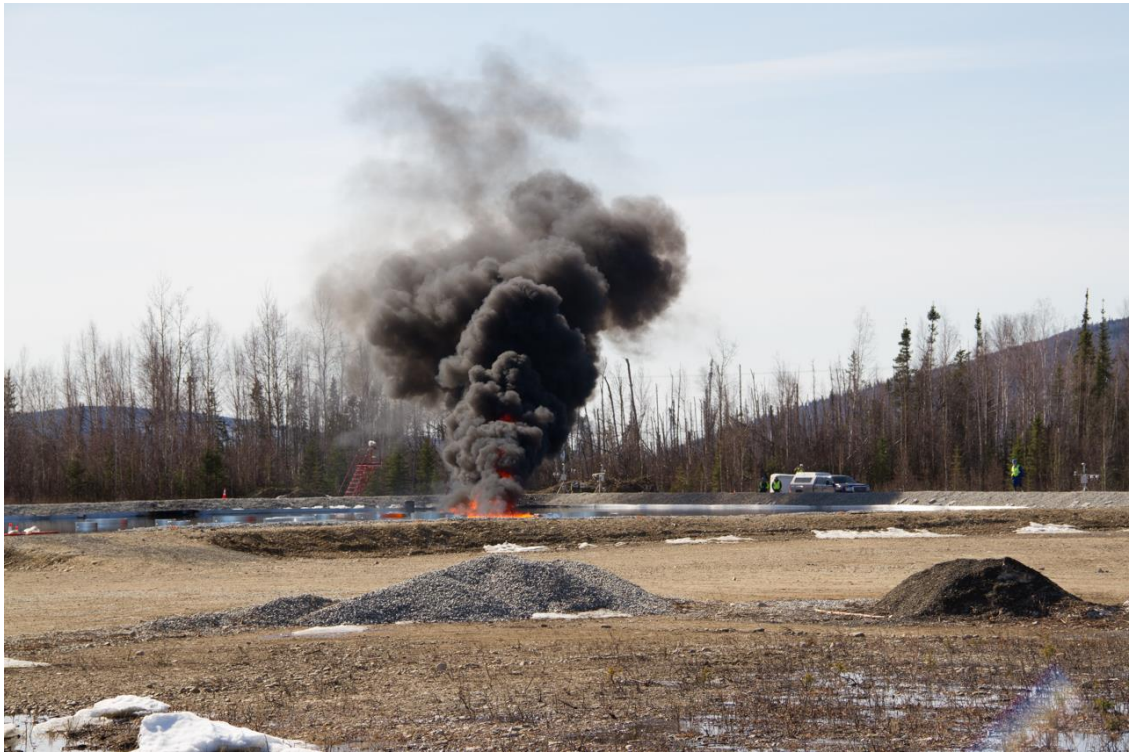
Figure ES-3: Heli-torch operation

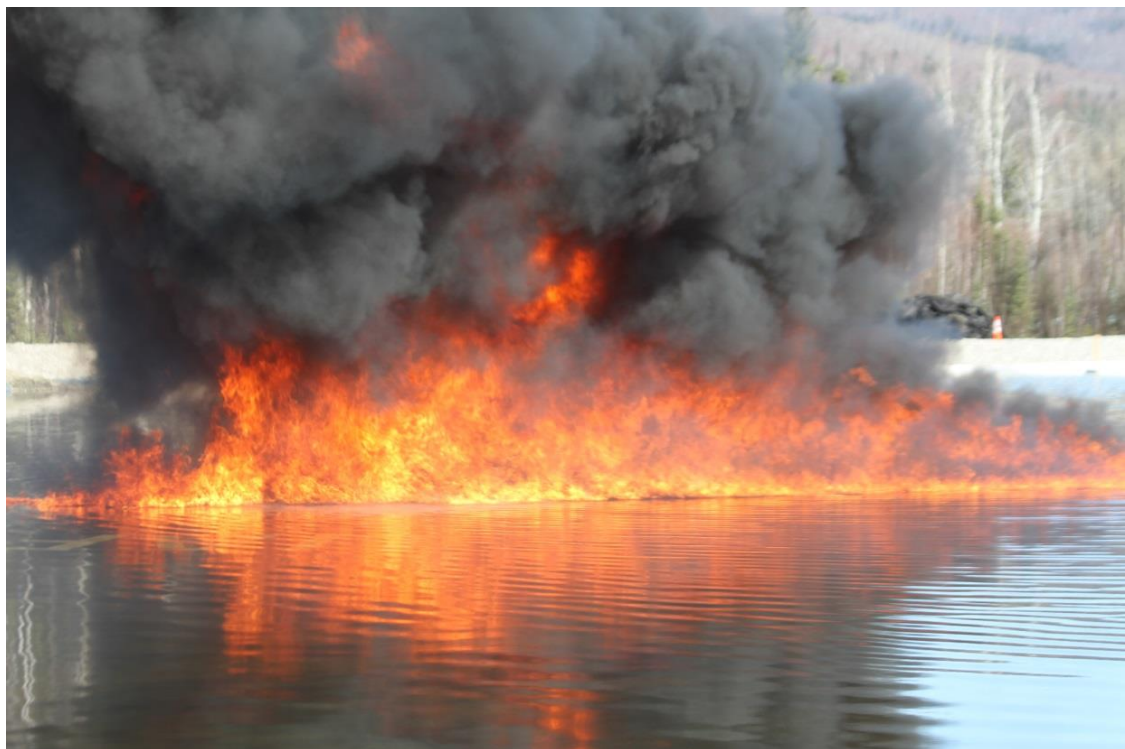
Figure ES-4: Successful burn of free-floating ANS crude oil slick herded with OP-40 in Test 3

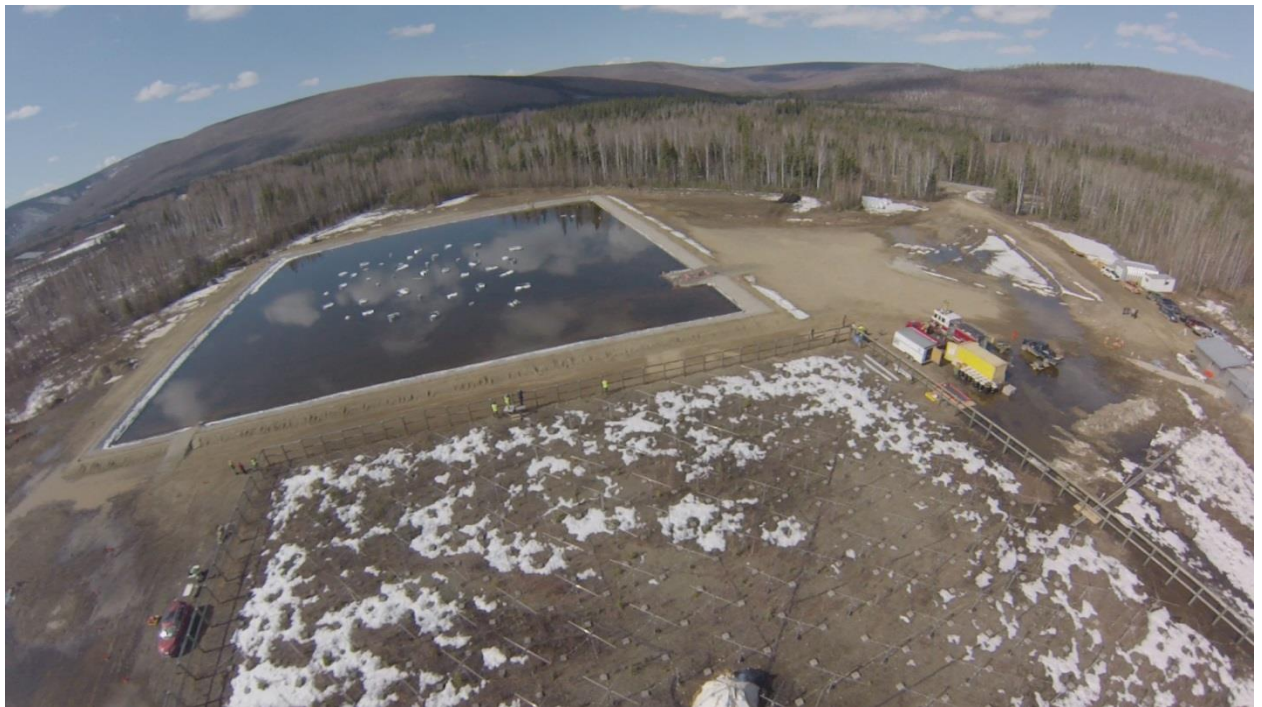
Figure 4: Aerial view of finished basin and site equipment locations

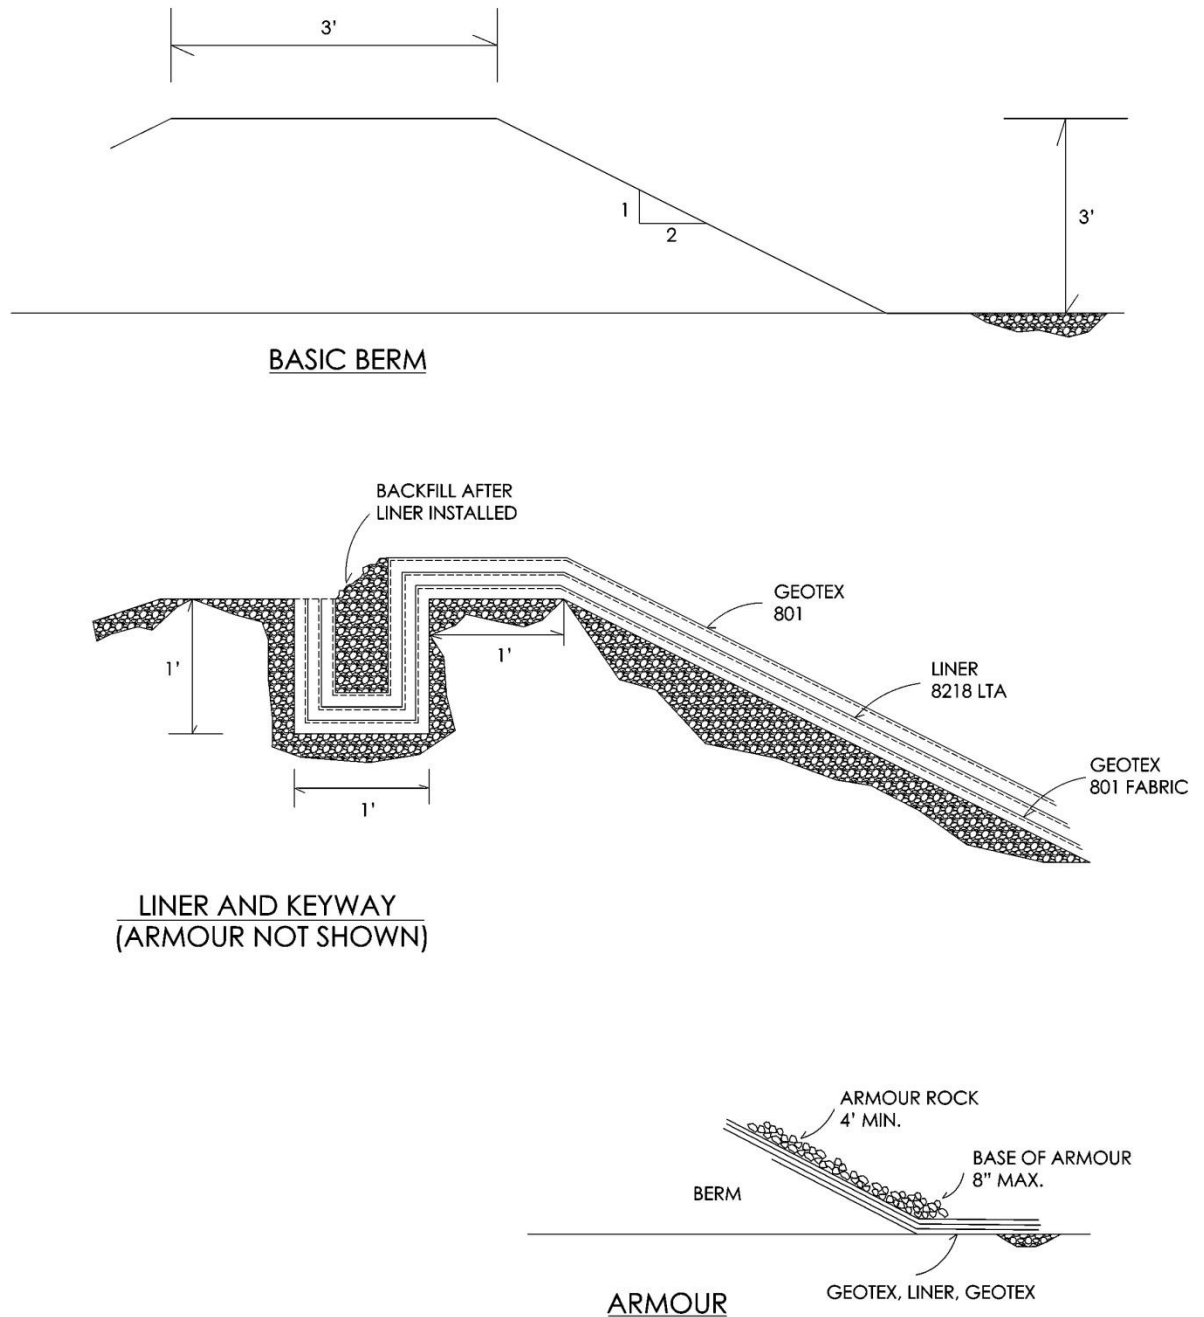
Figure 5: Berm and Liner Design (Cross-Section)

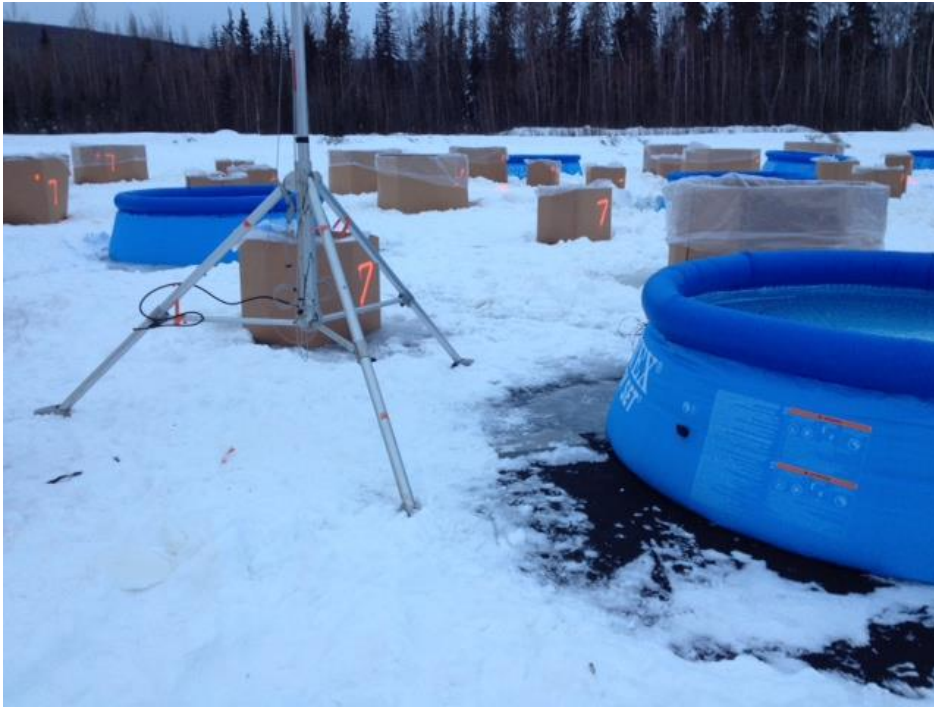
Figure 7: Cardboard boxes and children's pools used as forms to freeze water for ice floes

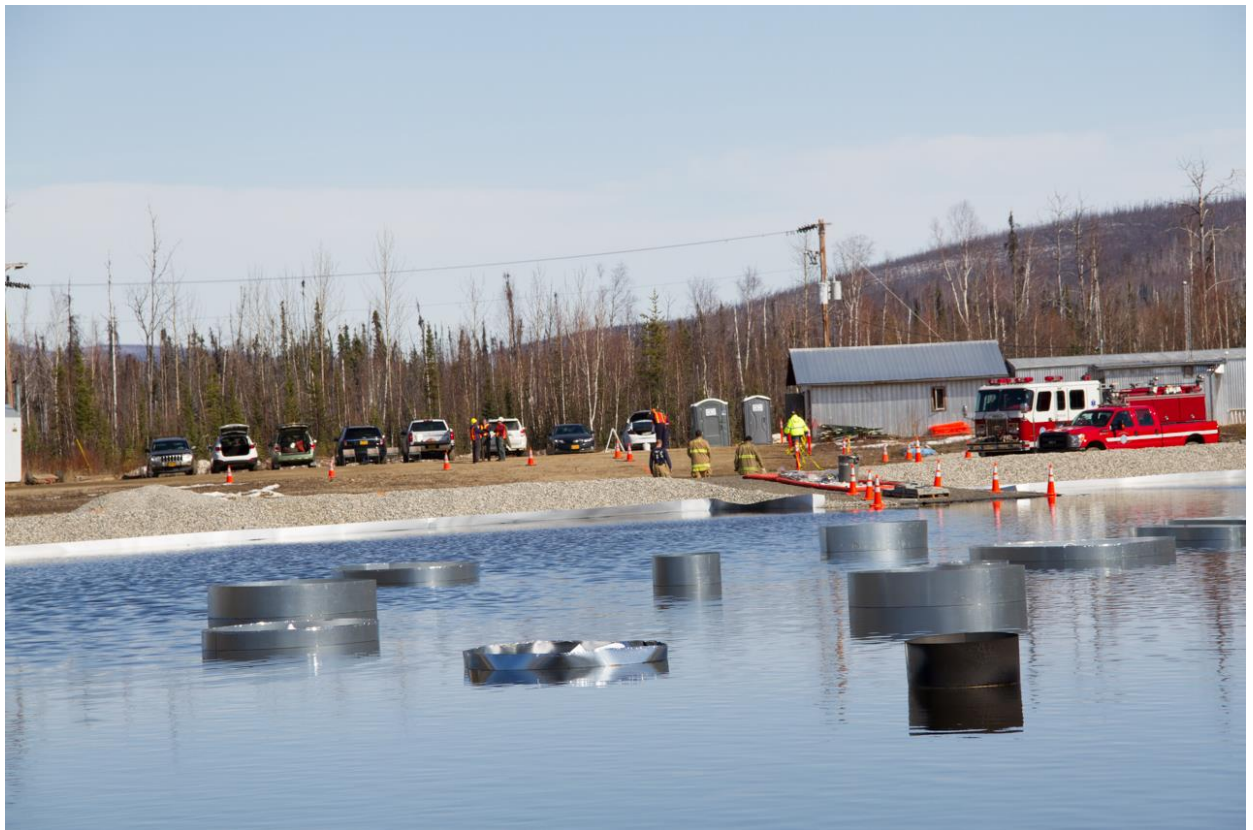
Figure 9: Sheet metal "faux" floes constructed to replace melting ice

It rapidly became evident that the ice floes would deteriorate to such an extent as to be inadequate by the start of the tests, so alternative "faux" ice floes were created. Inasmuch as the main purpose of the ice floes was as a mechanical barrier to oil spreading, metal rings of various sizes were constructed to act as ice floe surrogates. Galvanized metal flashing in 2.4 m (8 foot) lengths were formed into rings using one, two, or three lengths to form circles with approximately 1 m, 2 m, and 3 m (8-, 16-, and 24-foot) circumference (**Figure 9**). Large pieces of white sorbent were placed inside the sheet metal rings to provide contrast for the aerial photography. The rings were placed within the central portion of the tank providing "ice" coverage of approximately 6% (**Figure 10**).

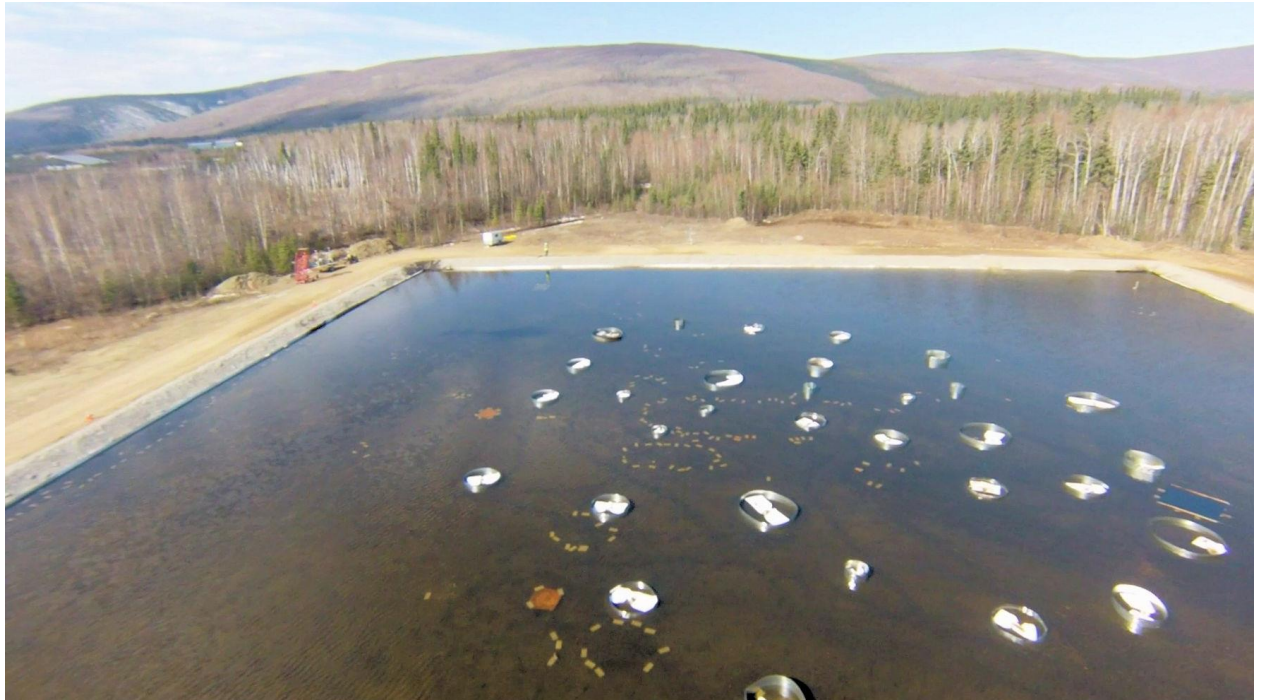
Figure 10: "Faux" floes in basin

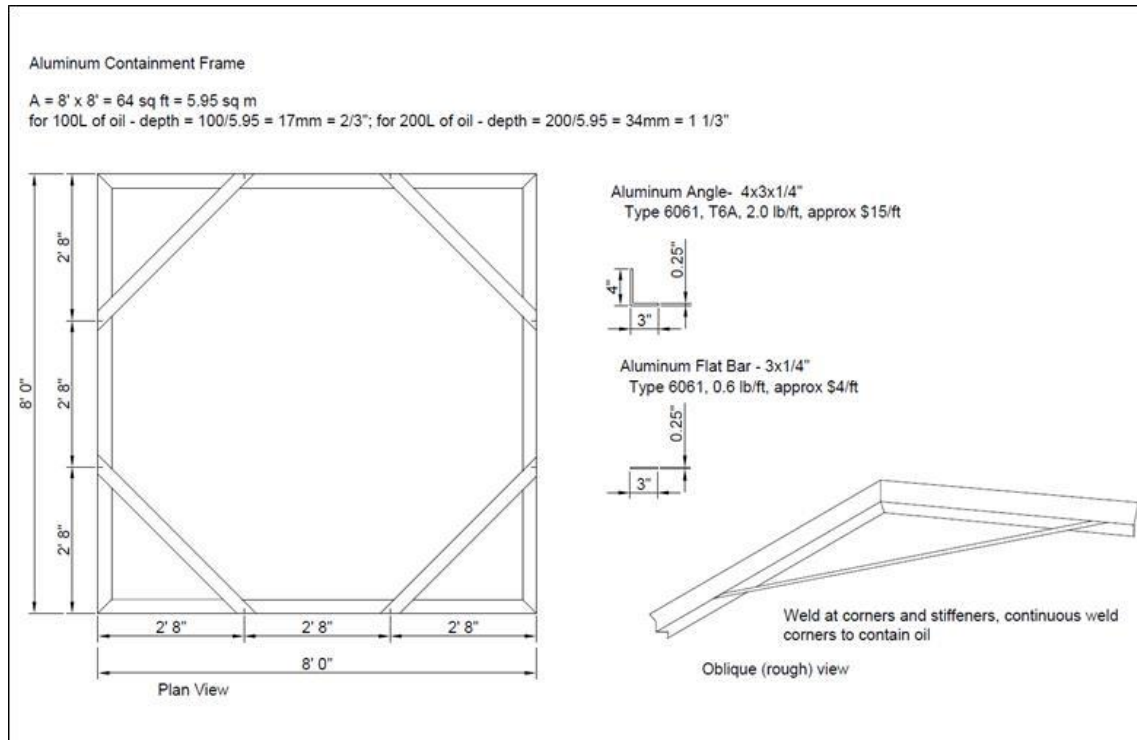
Figure 11: Aluminium angle release frame design sketch

square (**Figure 11**). The square was elevated by placing it on concrete paver blocks such that it had approximately 2.5 cm (1 inch) of freeboard. The selected volume of oil for each test, nominally either 100 or 200 litres, was then carefully poured into the ring (**Figure 12**). Stainless steel aircraft cable was attached to the frame and run to a position outside the basin at the upwind direction. When each test was initiated, workers pulled the cables to move the frame off its supports, dropping it below the water surface and causing the oil to be released (**Figure 13**).

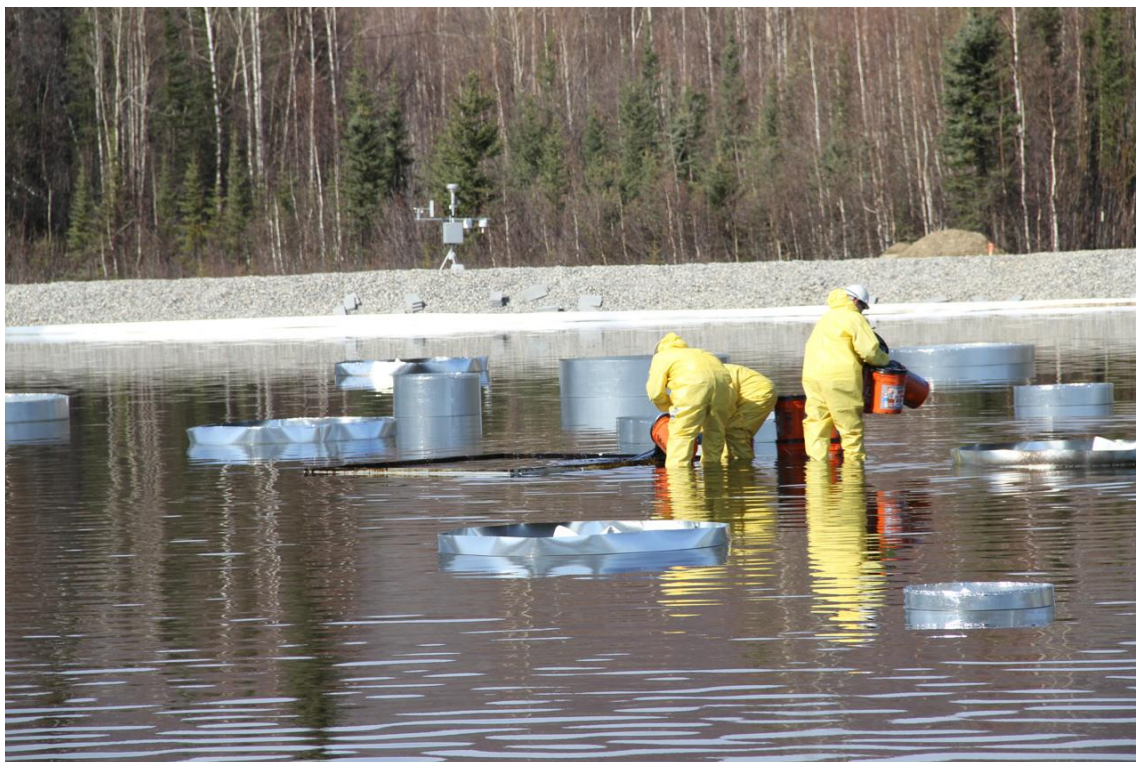
Figure 12: Pouring pre-weighed buckets of ANS crude into release frame in centre of "faux" floe field

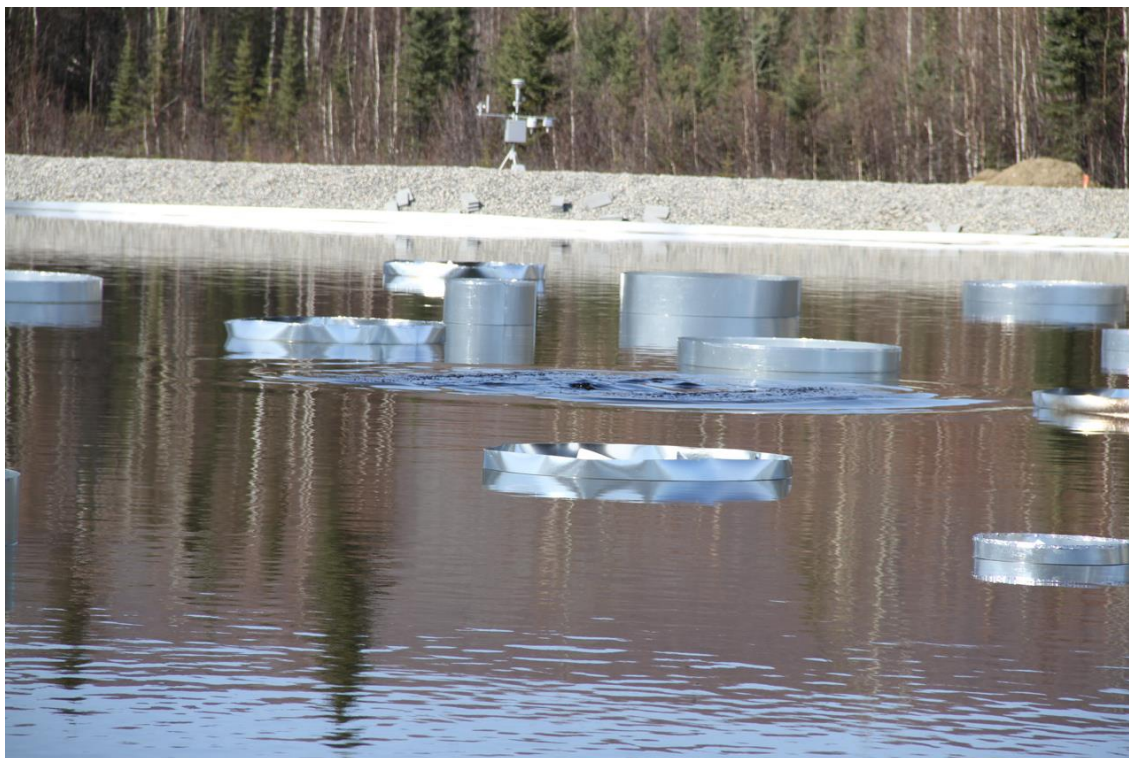
Figure 13: Release frame pulled off supports to release oil

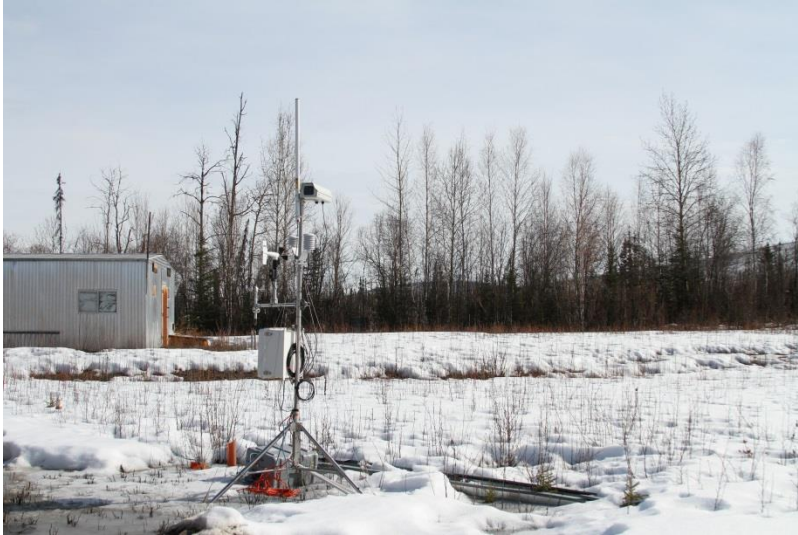
Figure 14: Portable meteorology station

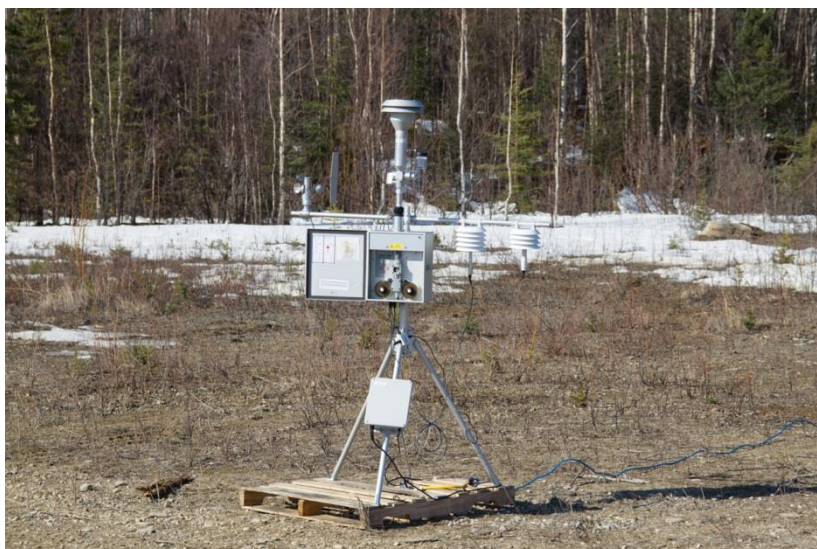
Figure 17: Stationary air sampler

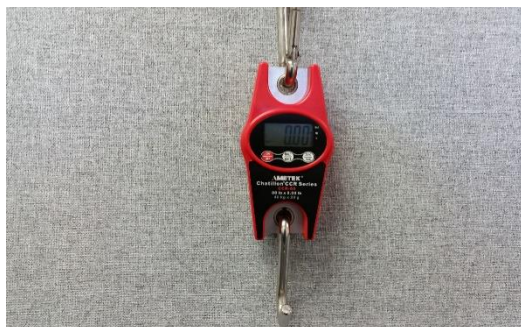
Figure 18: Digital Hanging Weigh Scale

To estimate the amounts of crude oil released for each test, the oil that had been delivered to the site in steel drums was pumped into numbered plastic buckets that were then weighed using a digital hanging scale (**Figure 18**). These buckets were subsequently carried out to the release frame and carefully poured into the frame using a spill plate to ensure that it did not splash or contact and stick to the basin liner (**Figure 12** above). Once a burn had extinguished, the burn residue and any unburned oil was carefully collected with pre-weighed sorbent, placed in a pre-weighed plastic bag and reweighed on a digital hanging scale (**Figure 19**). The losses of oil to evaporation were not measured.

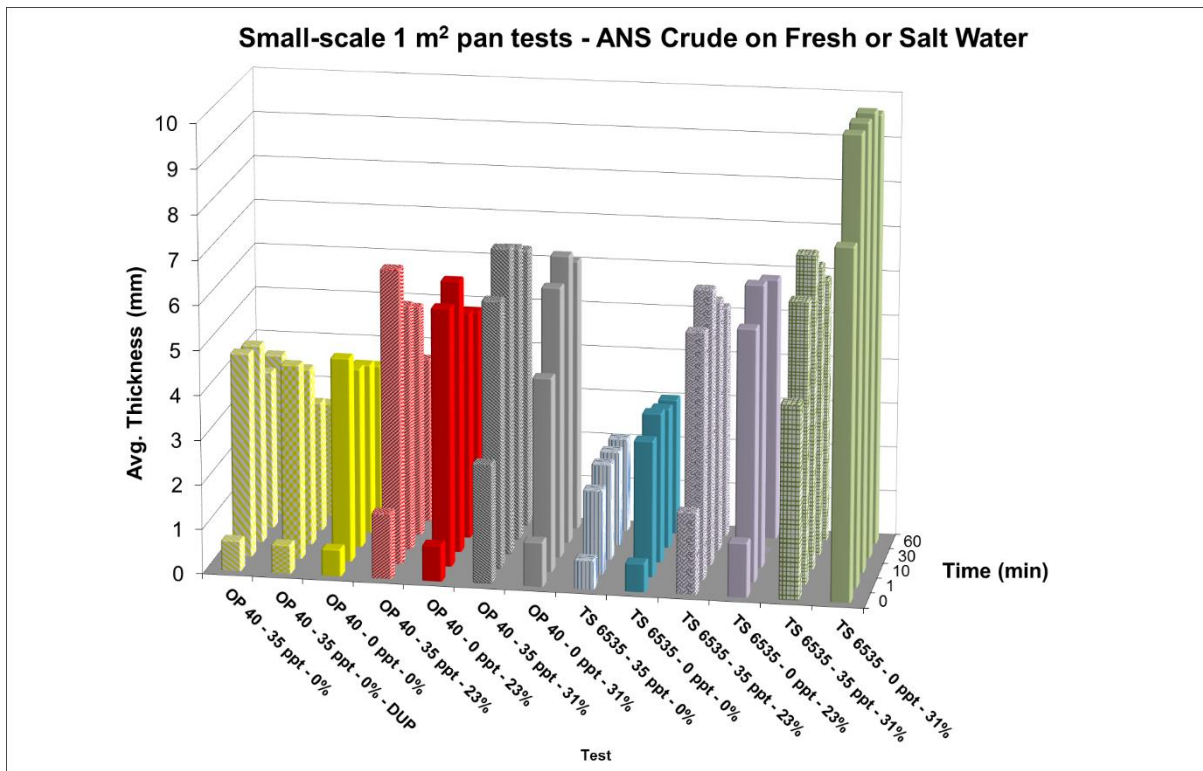
Figure 21: Laboratory Herder Test Results With Fresh ANS Crude

1. Both herding agents, ThickSlick 6535 and Siltech OP-40, were effective at herding fresh and moderately weathered oil.
2. Both herding agents, ThickSlick 6535 and Siltech OP-40, were similarly effective at herding oil on fresh and saline water. The large differences in herding effectiveness with the 31% evaporated crude are related to the oil's Pour Point (3°C) and not water salinity: the 31% evaporated oil gelled on the 0°C water.
3. Compared with previous herding studies with ANS crude, the herders were slightly less effective with the current blend of ANS, presumably due to slight changes in ANS composition.

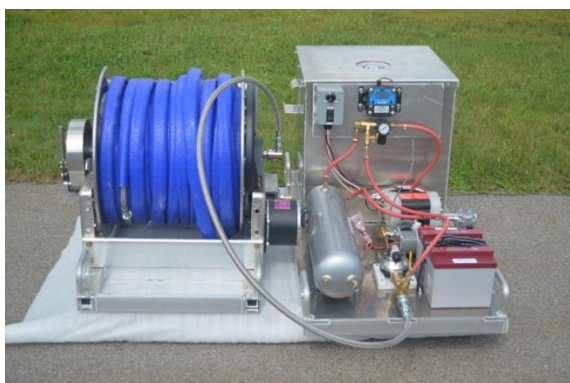
Figure 22: Initial Prototype Herder Application System Front

The DESMI AFTI herder application system was designed to transport and apply either OP-40 or ThickSlick 6535 from the open rear door of a commercial helicopter. The storage tank is insulated and carries up to 75 litres (20 US gallons) of herder. The system runs on 28V using aircraft quality components. It comprises two modules mounted on aluminium frames that are easily handled by two persons. The first module contains an extensible reel housing approximately 30 m (100 feet) of Stratoflex stainless steel hose with a Teflon liner. The second module houses an air-powered pump and air compressor capable of purging lines at the end of an application pass. It also contains a self-contained 28V battery array plus a 28V accessory cord for attachment to aircraft power systems, if available. Complete electrical circuit protection is provided with integrated circuit breakers, while multiple nozzles are enabled to adjust flow rate. The reel module with approximately 30 metres (100 feet) of hose has overall dimensions of 1.22m x 0.81m x 0.74m (48"L x 32"W x 29"H) and weighs approximately 91 kg (200 lbs.) when the hose is full of herder. The pump and tank module (see **Figure 22** and **Figure 23**) has overall dimensions of 1.22 x 0.61 x 0.61m (48"L x 24"W x 24"H), and weighs 84 kg (185 lbs.), plus up to 73 kg (160 lbs.) of herder.

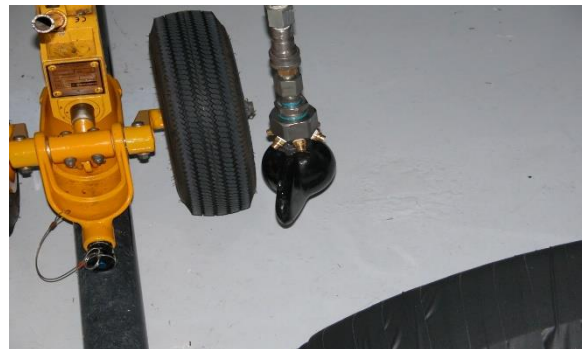
Figure 39: 5.5kg weight on end of nozzle

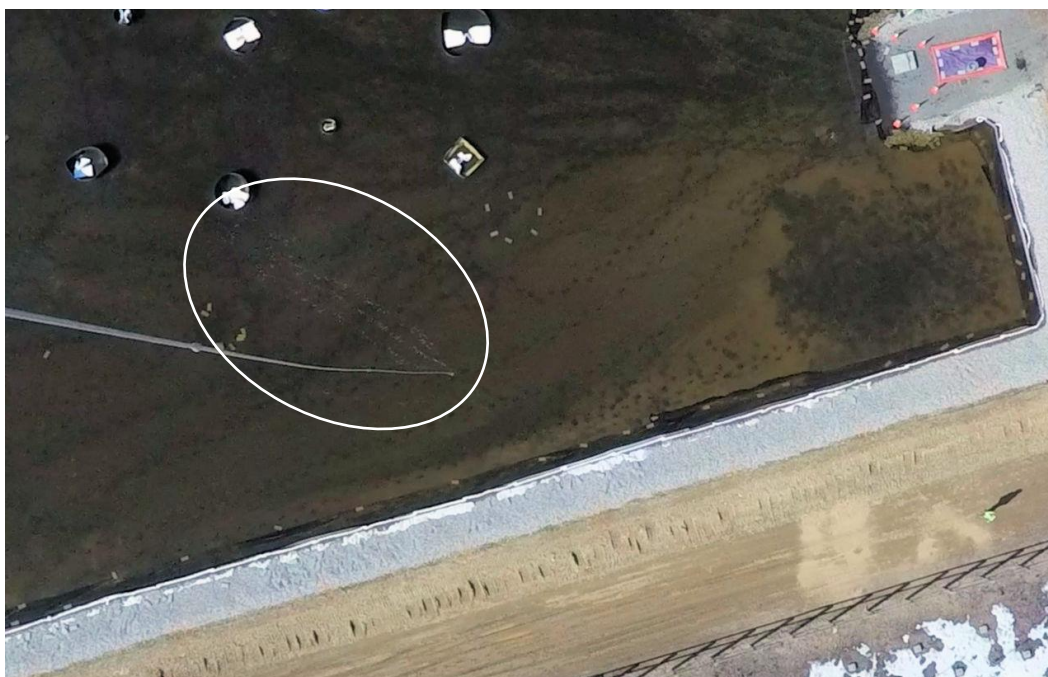
Figure 41: View from helicopter of herder spraying from nozzles (Test 1)

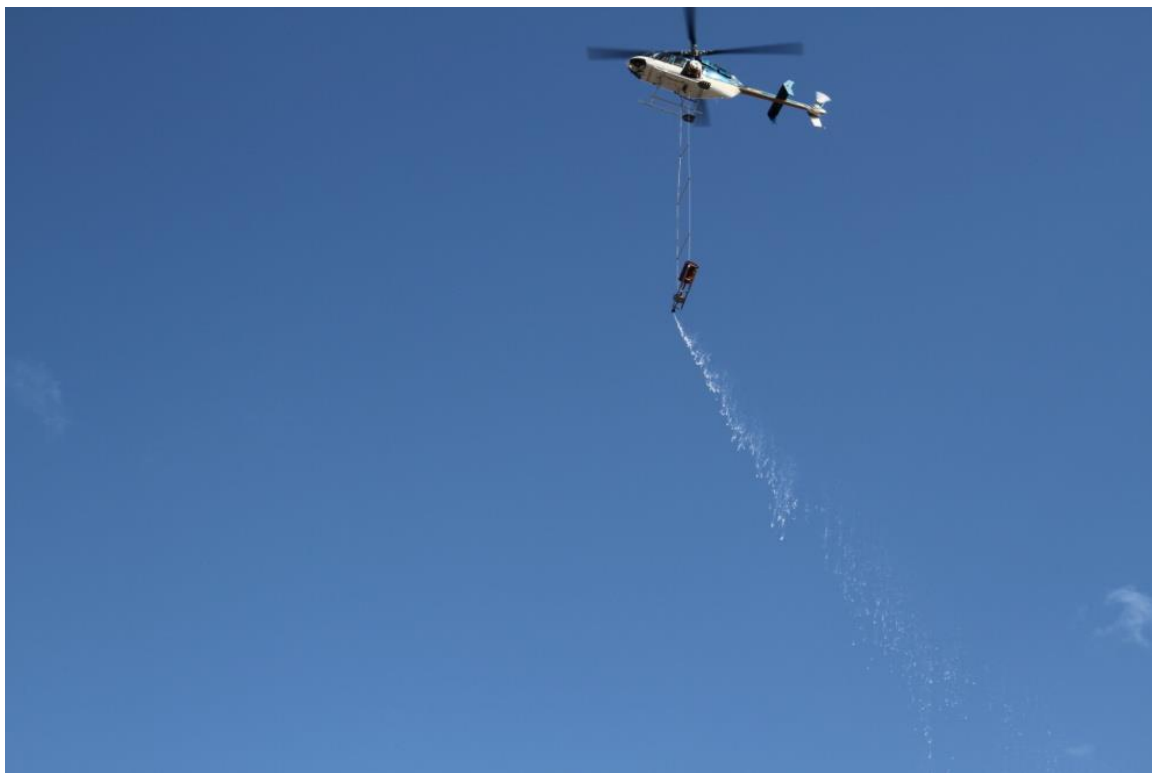
Figure 42: Diesel / gasoline mix failing to ignite from Heli-torch

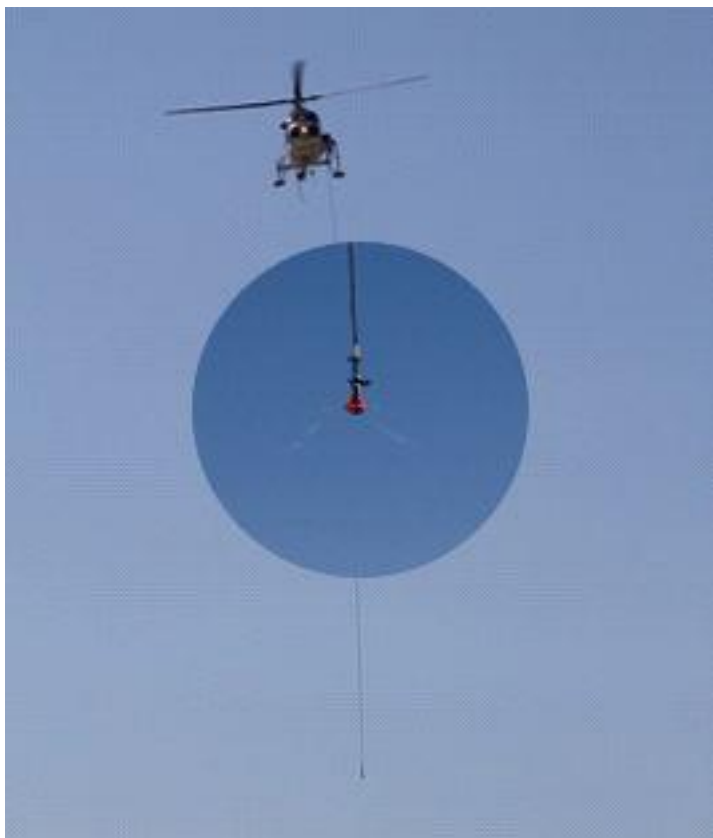
Figure 44: Helicopter with herder spray nozzle in position for Test 2

³ The #0002 nozzles initially selected, were not the “fan” type that the research in College Station suggested, and produced droplets slightly above the target range which would be less affected by rotor wash.

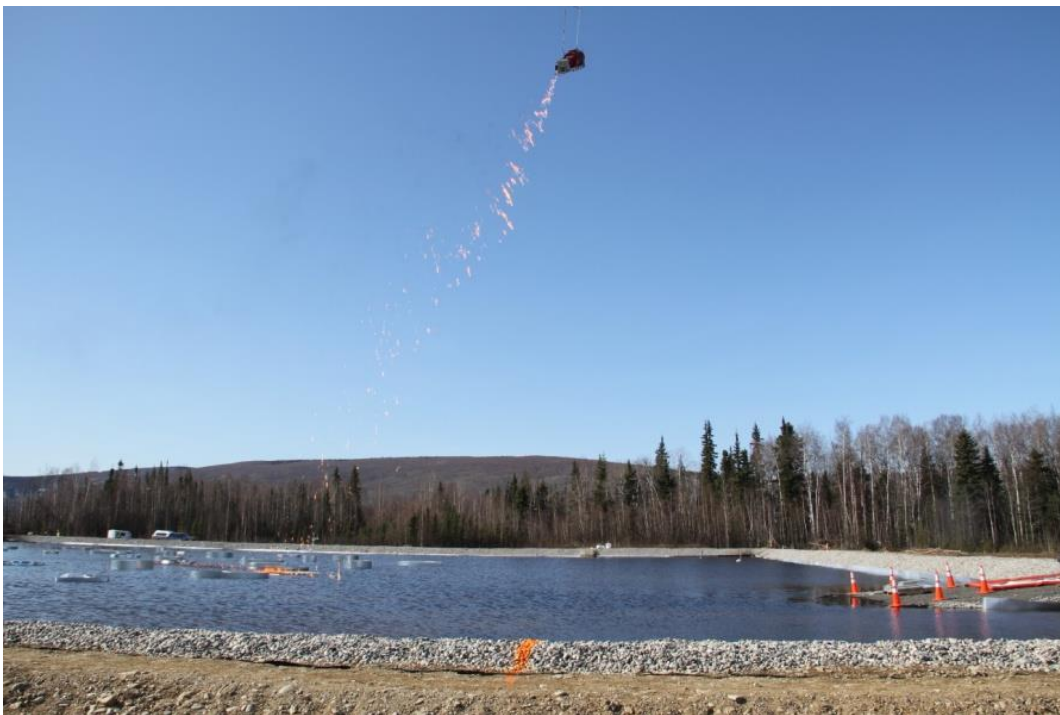
Figure 47: Successful Heli-torch test with 85:15 mixture of gasoline and diesel and longer gelling time

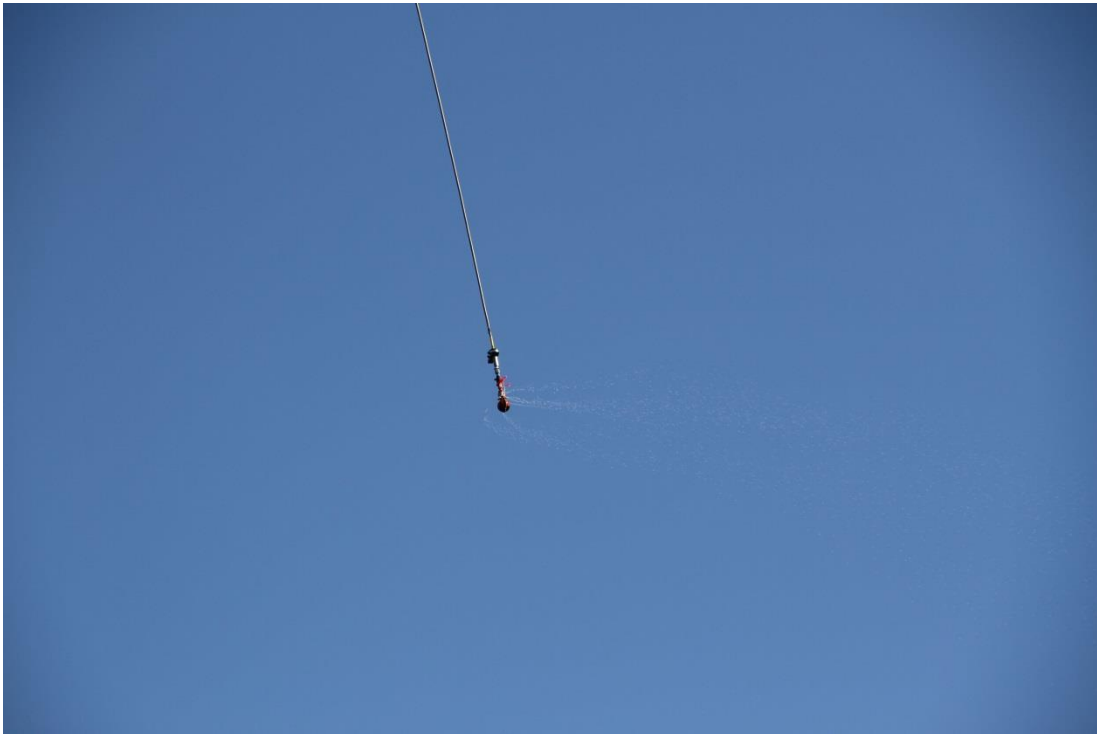
Figure 48: OP-40 spraying from nozzles in flight (Test 3)

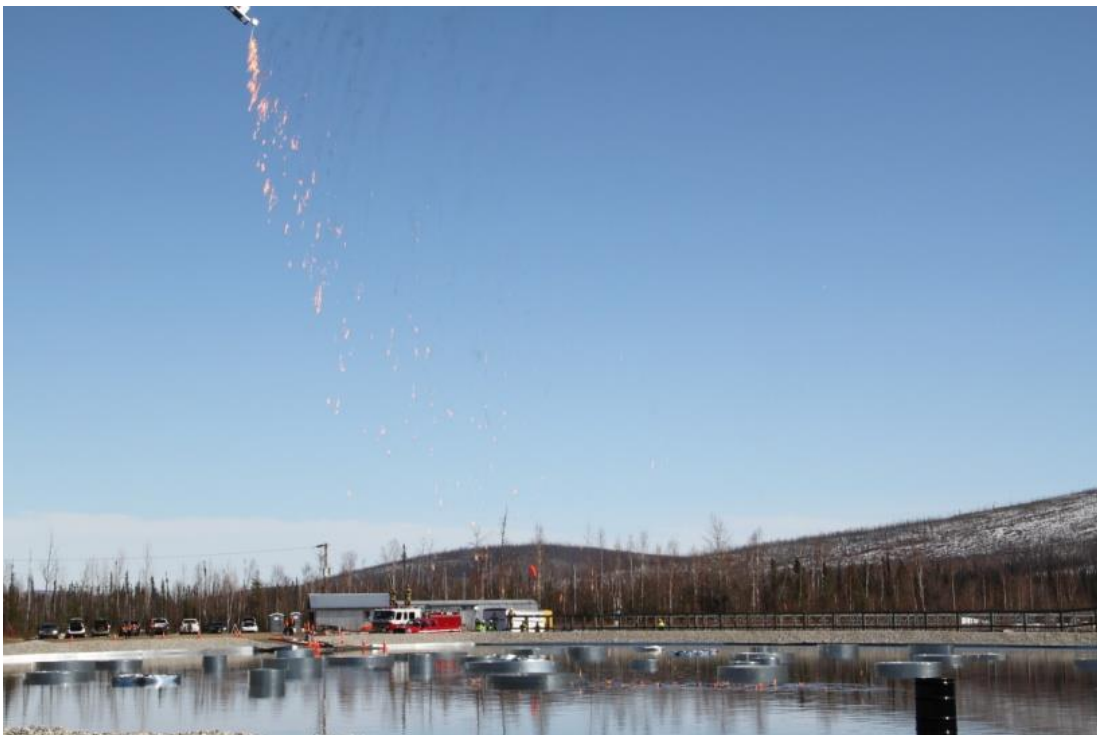
Figure 49: Burning gelled fuel hitting slick

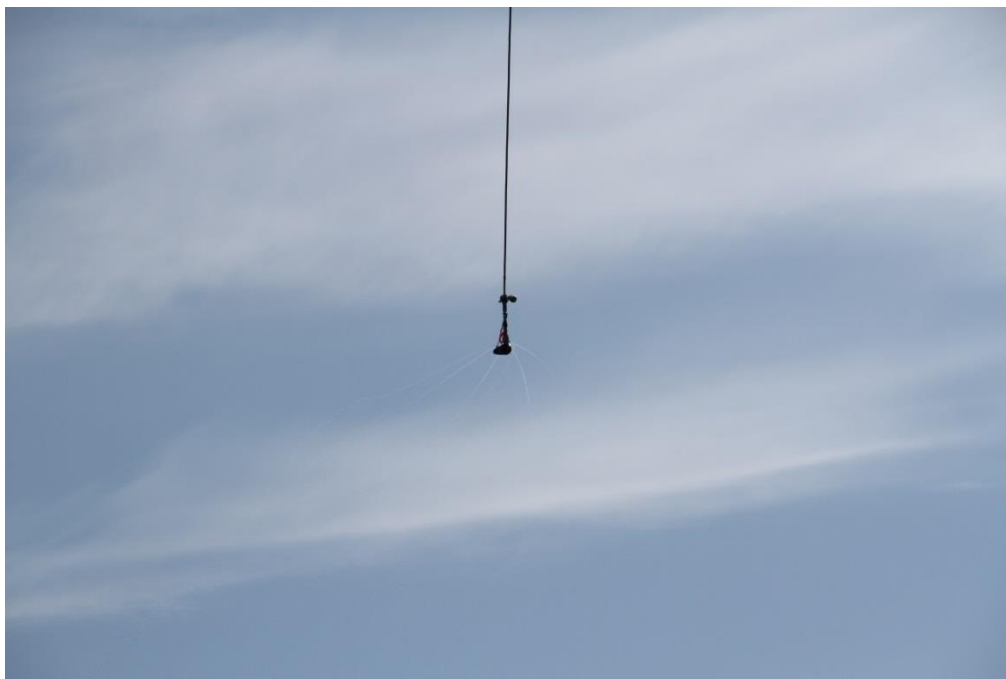
Figure 54: Herder streaming from nozzle when air pressure used to purge system at end of Run 4

After Test 4 was complete, a set of bench-scale experiments with the herding agents were undertaken to determine the possible causes of incomplete herder deployment during Test 4. Based on these tests, it was discovered that when a small amount of water was added to OP-40, it almost instantly became a viscous gel. The same, but less dramatic, behaviour was noted when a small amount of water was added to ThickSlick 6535. Additional bench-scale tests indicated that diesel fuel mixed with the herders did not cause gelling later tests indicated that iso-propyl alcohol mixed with the herders did not cause gelling either.

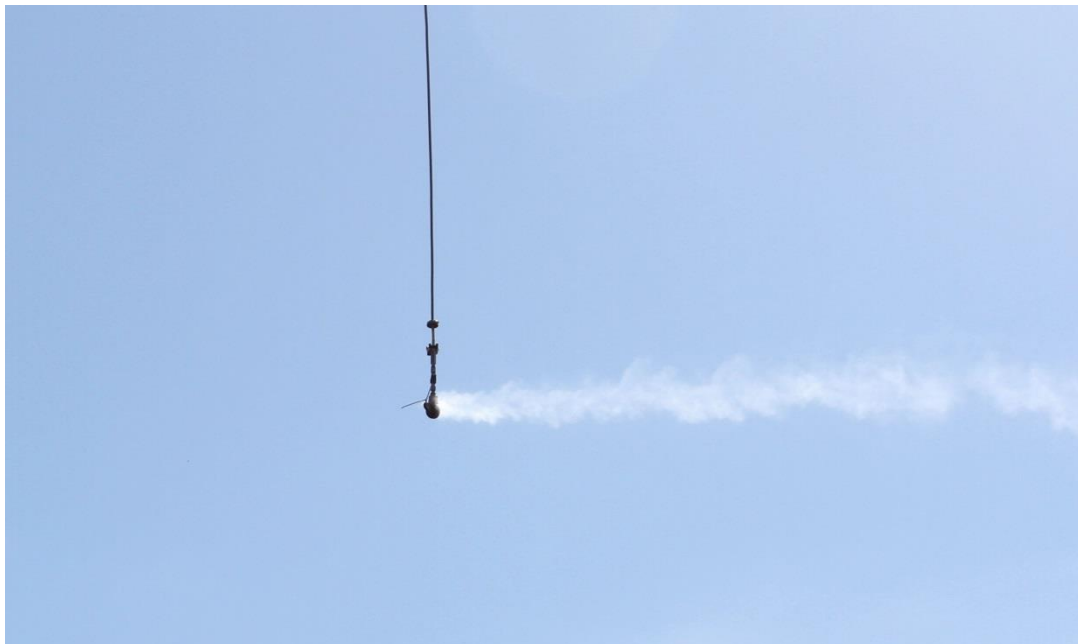
Figure 57: Good atomization of TS 6535 during Test 5 application

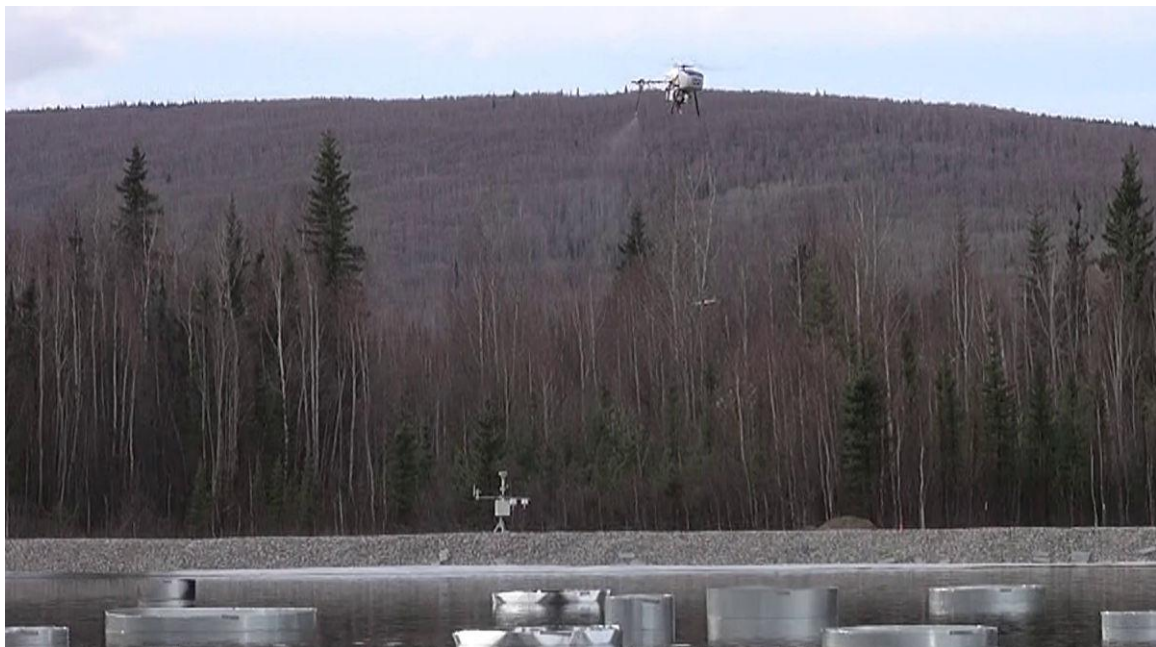
Figure 61: Responder UAV spraying water to simulate herder application

On the morning of Sunday April 26 the circuit board was installed and qualification flights were conducted from late-morning through 4:00pm at the “Balloon Inflation Area” of PFRR. The repaired UAV was transferred to the test basin and conducted a test run involving simulated herder application, followed by activating, then dropping a modified marine flare igniter. The herder application spray system worked well, when spraying water to simulate herder (**Figure 61**).

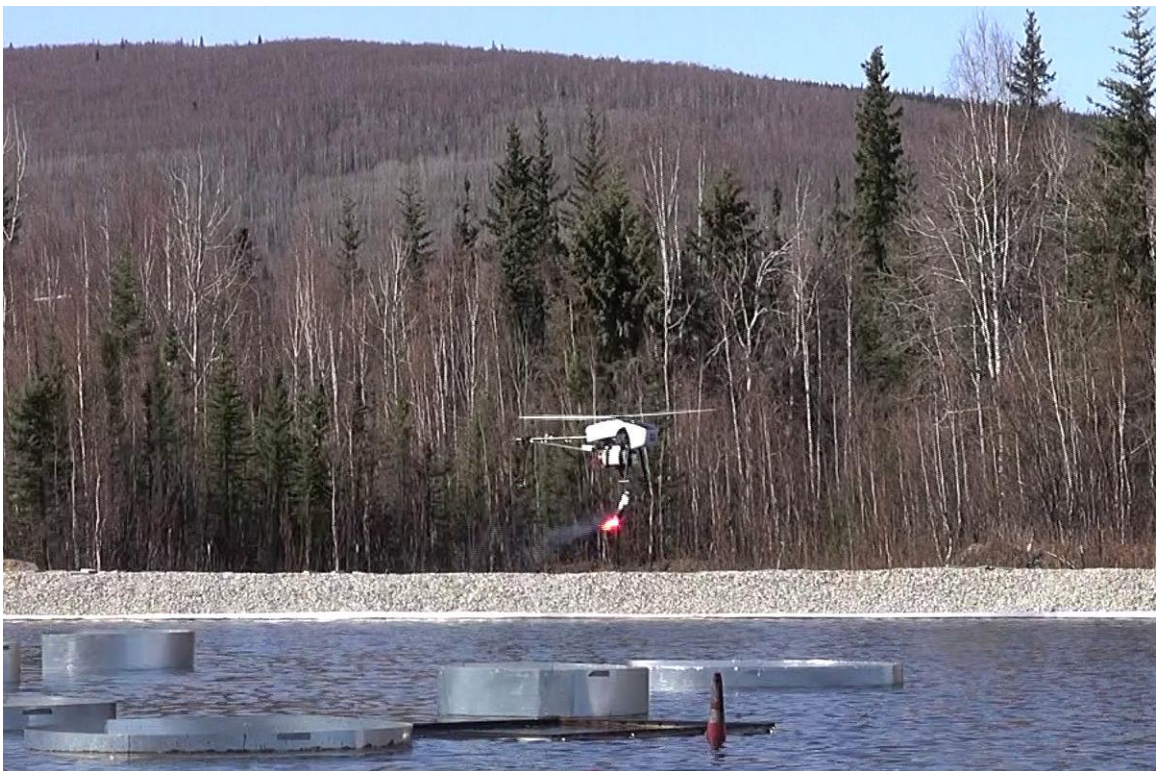
Figure 64: UAV Responder with active modified flare

A final UAV test, without oil, was conducted on Tuesday April 28. The targeting camera was reprogrammed overnight and made operational for the flight. The Responder was able to successfully fly with the herder application payload, then ignite and drop a marine flare within the target area (see **Figure 64** through **Figure 66**).

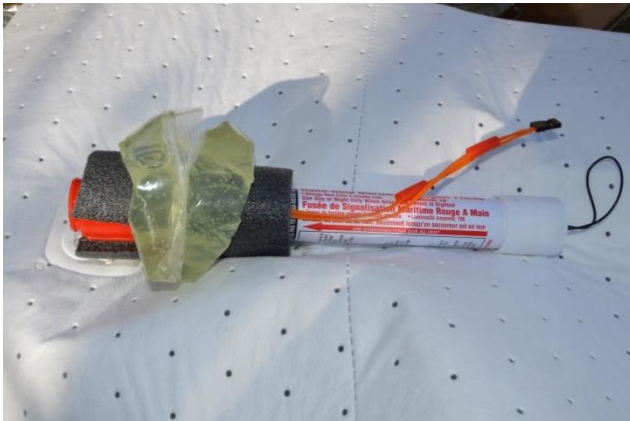
The fully assembled marine flare system with electronic match initiator, foam floatation, gelled gasoline, and counterweight embedded in the white cap in Figure 67.

Figure 67: Marine Flare based Igniter System
