**ARCTIC
RESPONSE
TECHNOLOGY**
OIL SPILL PREPAREDNESS

January 20, 2016

S. Potter, I. Buist, D. Cooper - SL Ross Environmental Research Limited
W. Schnabel, J. Garron, R. Perkins, S. Aggarwal, R. Bullock -
University of Alaska Fairbanks
P. Lane - DESMI

FIELD RESEARCH ON HELICOPTER APPLICATION OF CHEMICAL HERDERS TO ADVANCE IN-SITU BURNING

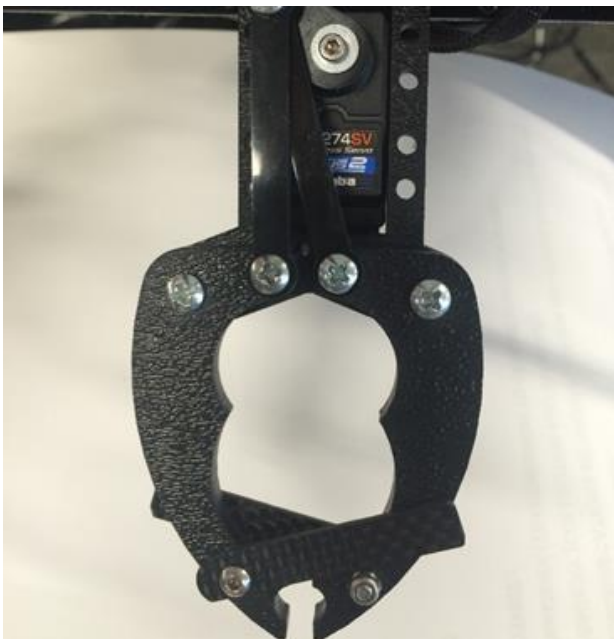
ING Robotics redesigned the igniter retention system (Figure 68) and initiated testing of loads well in excess of the expected igniter weight to ensure the servo controlling the system would not overheat. Roughly 100 tests have been completed with a range of weights between 0.2 lb and 2.2 lb without failure.

Figure 68: Retaining claw with redesigned retention bars

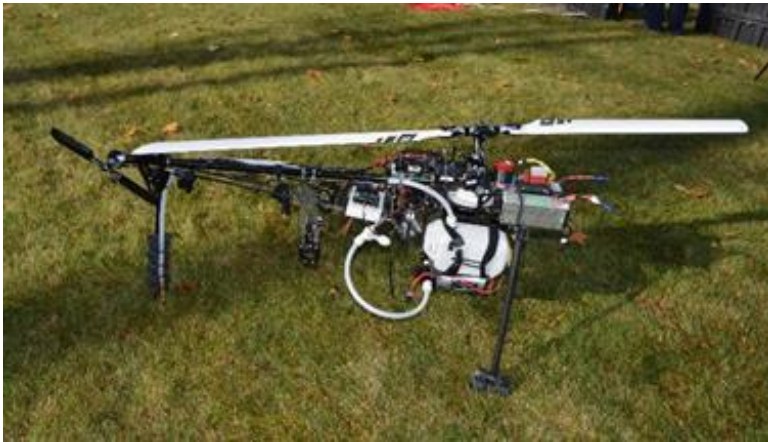
Figure 69: Responder with Herder Application System

Herder application testing was performed on November 3, 2015 under sunny conditions with temperatures ranging from 10 to 12 °C during the testing. Wind was from the northwest at approximately 15 km/h but did not pose much of a challenge for the UAV. Herder application passes were performed at altitudes in the 2 to 3 metre range, at speeds around 3 to 5 m/s. Figure 73 shows the UAV beginning one of the herder application passes, while Figure 74 shows the herder being sprayed from the application nozzle, with the Marine Flare Igniter System in the foreground. Figure 75 and Figure 76 show the results of the herder application on the oil trays.

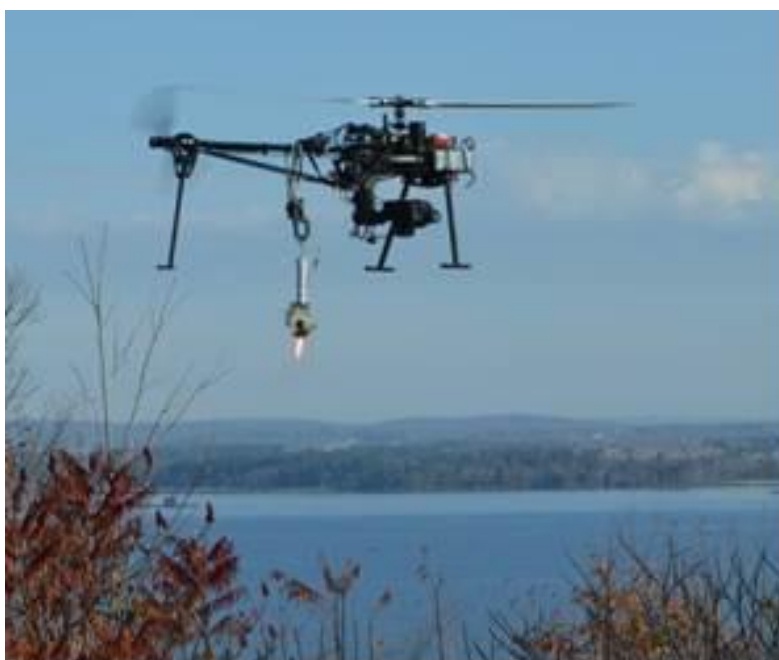
Figure 77: Responder triggering modified flare ignition

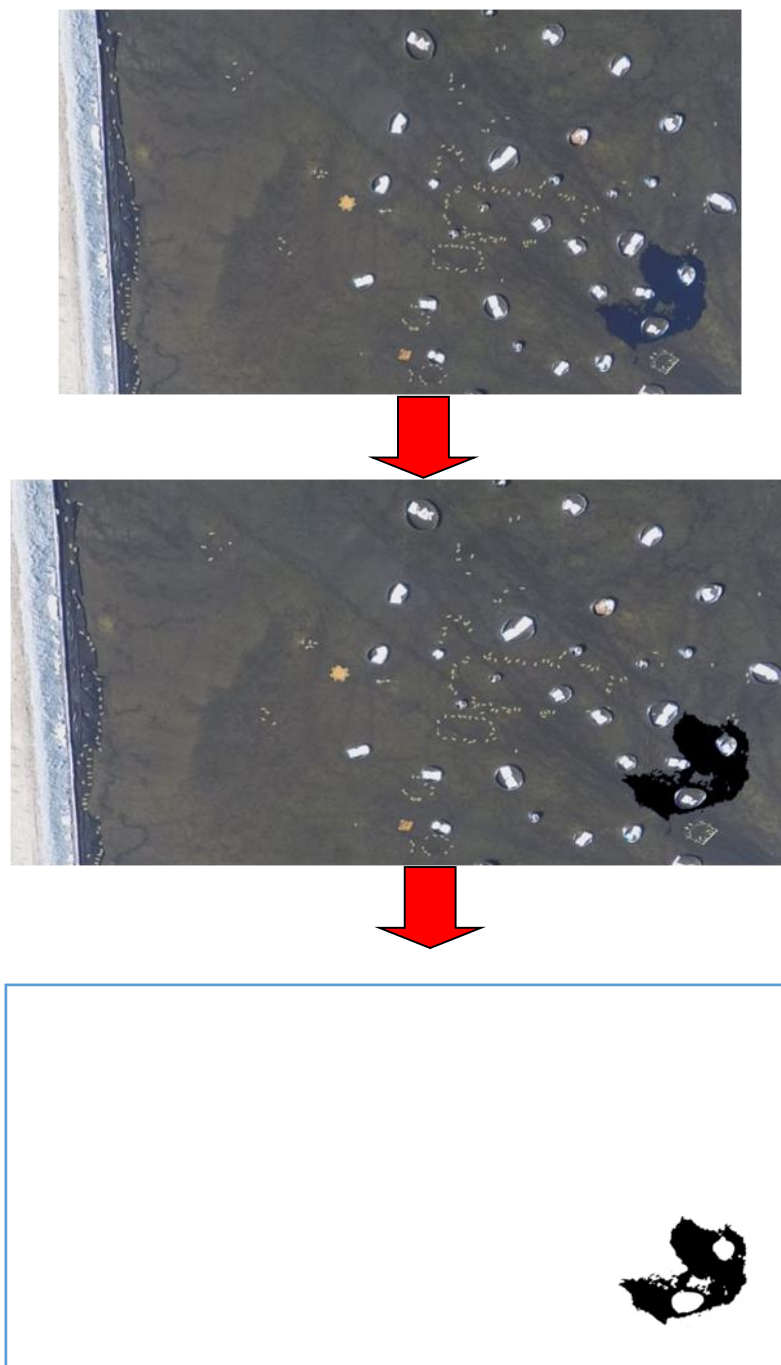
Figure 79: Digital transformation of aerial photographs to determine slick area

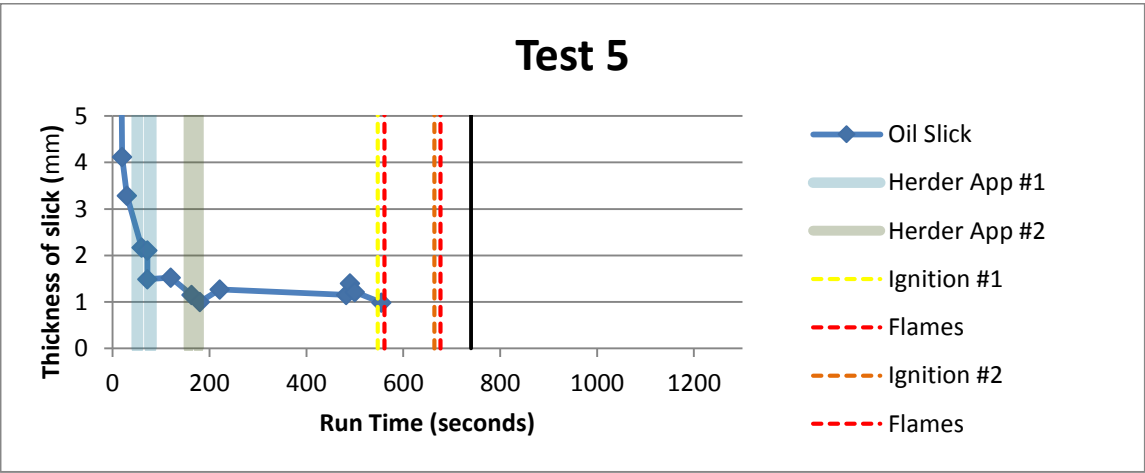
Figure 89: Thickness of Test 5 Oil Slick vs. Time

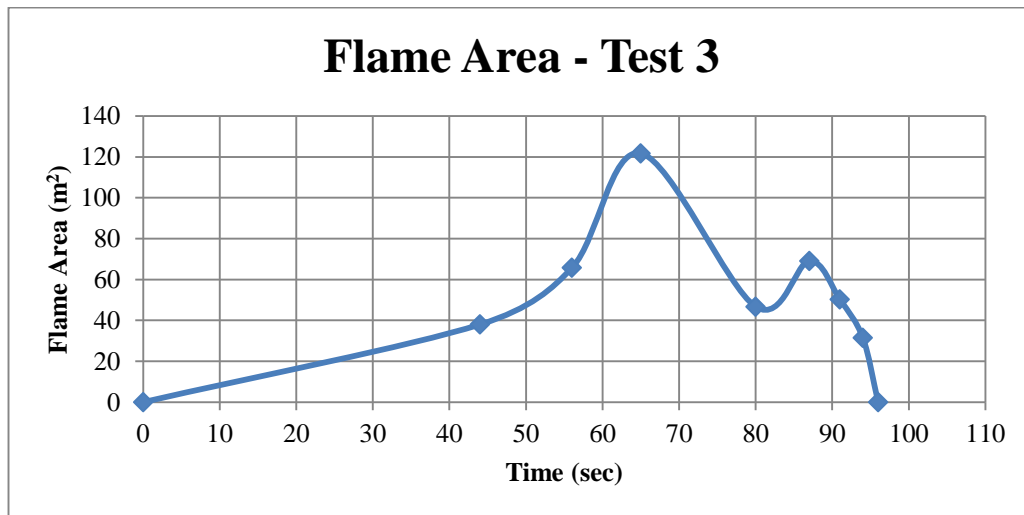
Figure 90 shows the burn area data collected for Test 3 (151 litres of ANS herded with OP-40). Using Equation 2 with an area-time integration of 3800 m²s gives an oil volume burned estimate of 110 litres. Using the Maximum Burn Area approach results in an estimated burn volume of 120 litres. Based on this, the burn in Test 3 resulted in the removal of approximately 70 to 80% of the oil.

Figure 90: Flame area data for Test 3

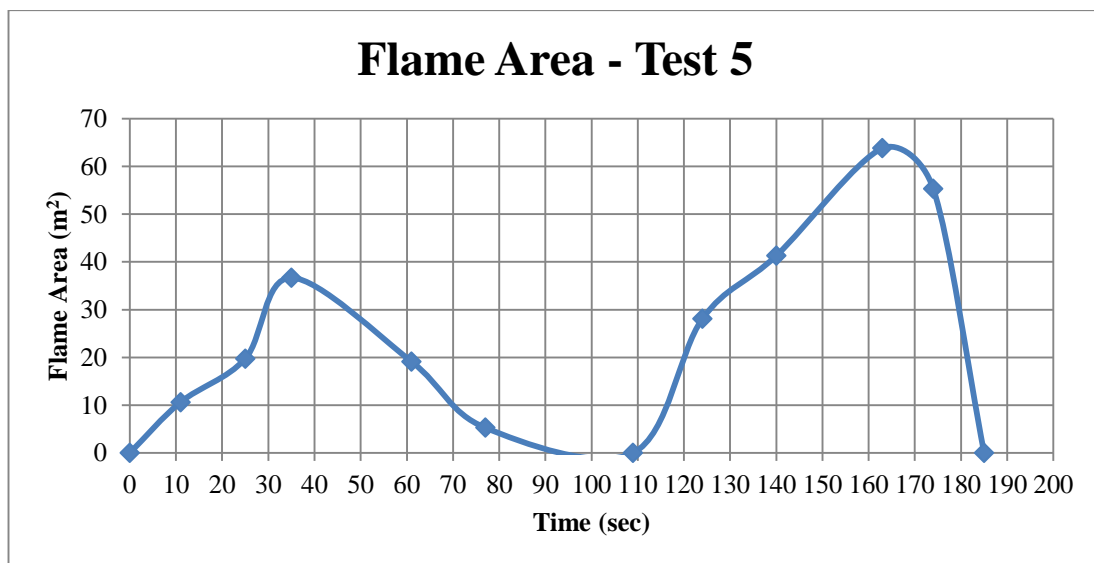
Figure 91 shows the burn area data collected for Test 5 (154 litres of ANS herded with TS6535). Using the Integrated area-time approach with a value of 1500 m²s for the first burn and 2900 m²s for the second burn gives a total oil volume burned estimate of 130 L. Using Equation 3 results in an estimated burn volume of 40 litres for the first burn and 75 litres for the second for a total of 115L burned. Based on this, the burn in Test 5 resulted in the removal of 75 to 85% of the oil using herding and burning applied from a helicopter.

Figure 91: Flame area data for Test 5

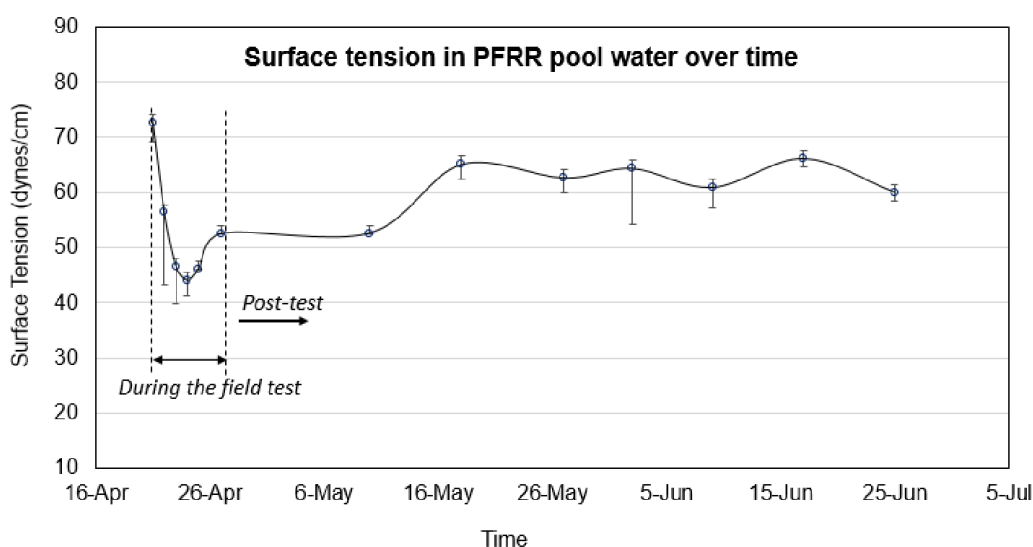
Chemical herders reduce the surface tension, thus surface tension values act as a surrogate for herder concentration values in the water column. Lower surface tension values indicate higher herder concentrations. Surface tension values are routinely used in laboratory and field scale herding studies/operations to quantifiably estimate the herder concentrations. Thus, for the chemical herder mediated in-situ burning study, samples were systematically collected for surface tension measurements before the test commenced (to collect baseline data), during the tests and after the tests; to track herder concentrations and subsequent post-test degradation. The results of these measurements are presented in Figure 1.

Figure 1: Surface tension results from Poker Flat test basin (2015)

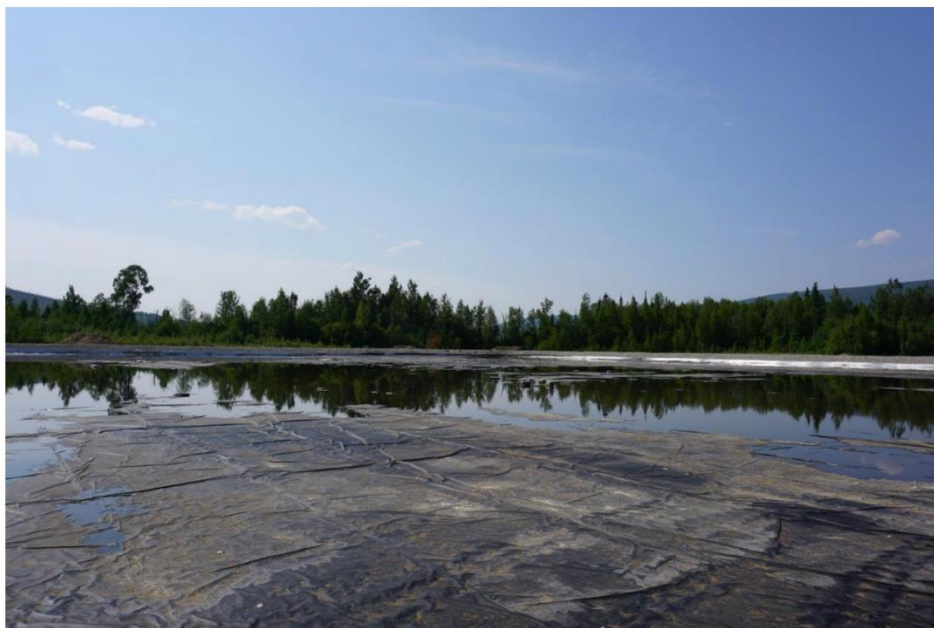
Our team has visited the basin weekly following the tests to collect samples and make observations. During those visits, we noted that there is no visible petroleum sheen, and also that the basin water level has dropped considerably due to evapotranspiration. On our 7/4/15 visit, we noted that approximately 40% of the basin area was dry, with the remaining water existing only in the low spots. Given that the basin bottom is relatively flat, the residual water likely accounts for much less than 10% of the approximately 400,000 gallons present during the April field tests. A picture of the basin on that 7/4/15 visit is presented in Figure 2.

Figure 2: Basin condition on 7/4/15.

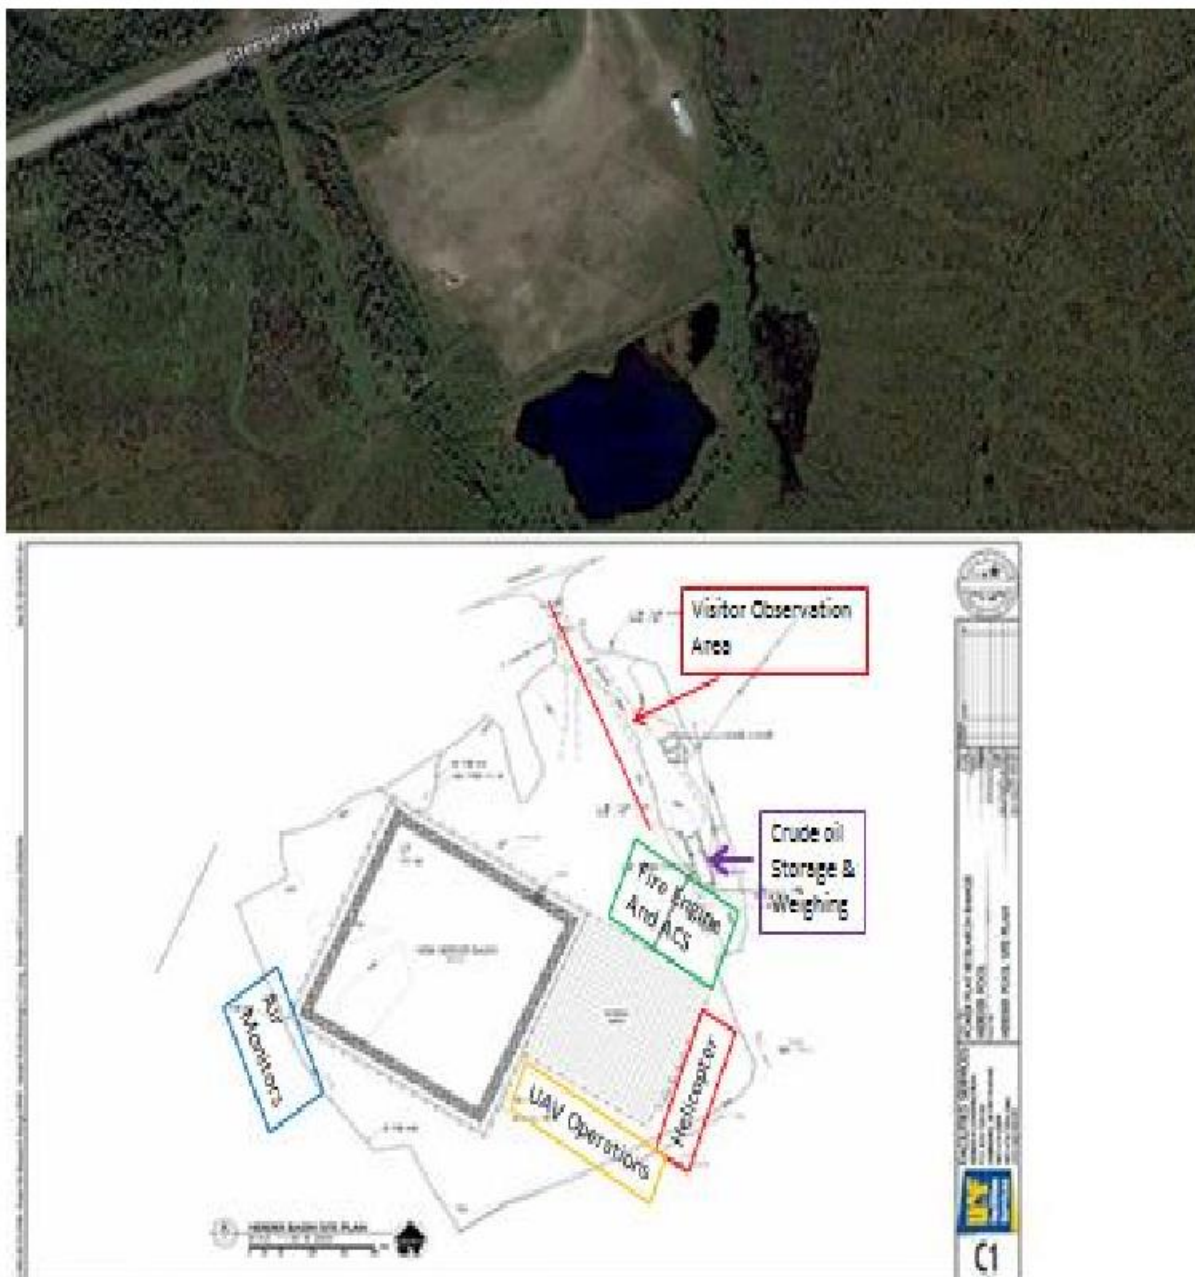
Figure B-1: Plan view of test site

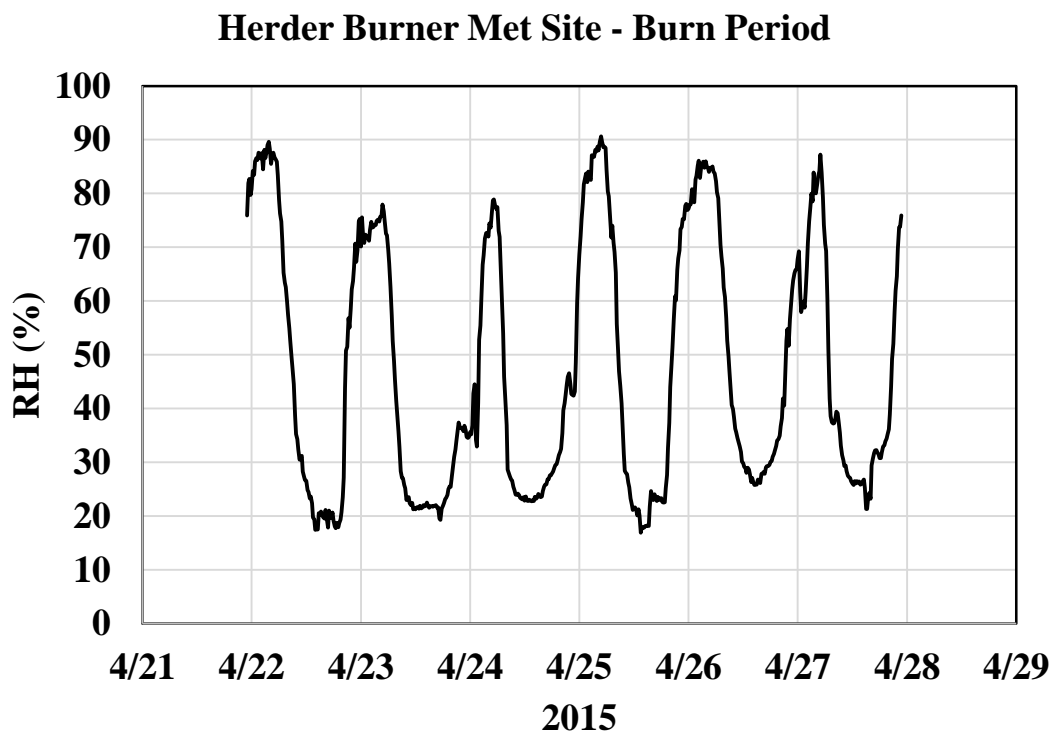
Figure C-2: Relative Humidity During Testing

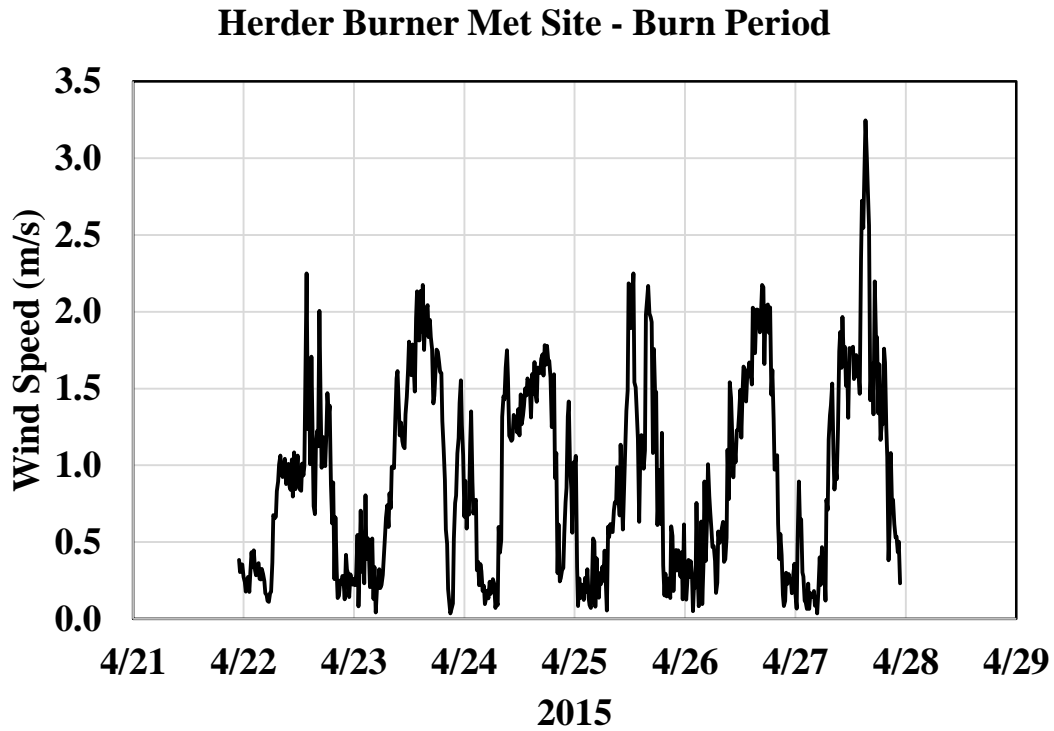
Figure C-3: Wind Speed During Tests

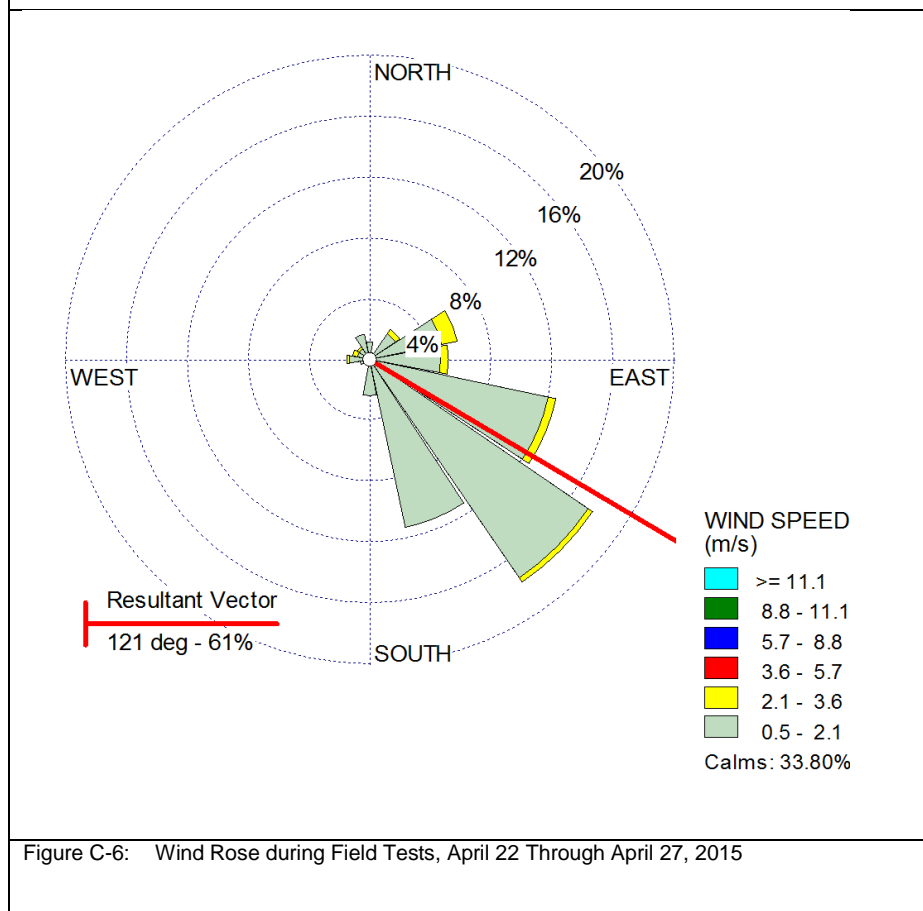
Figure C-6: Wind Rose during Field Tests, April 22 Through April 27, 2015

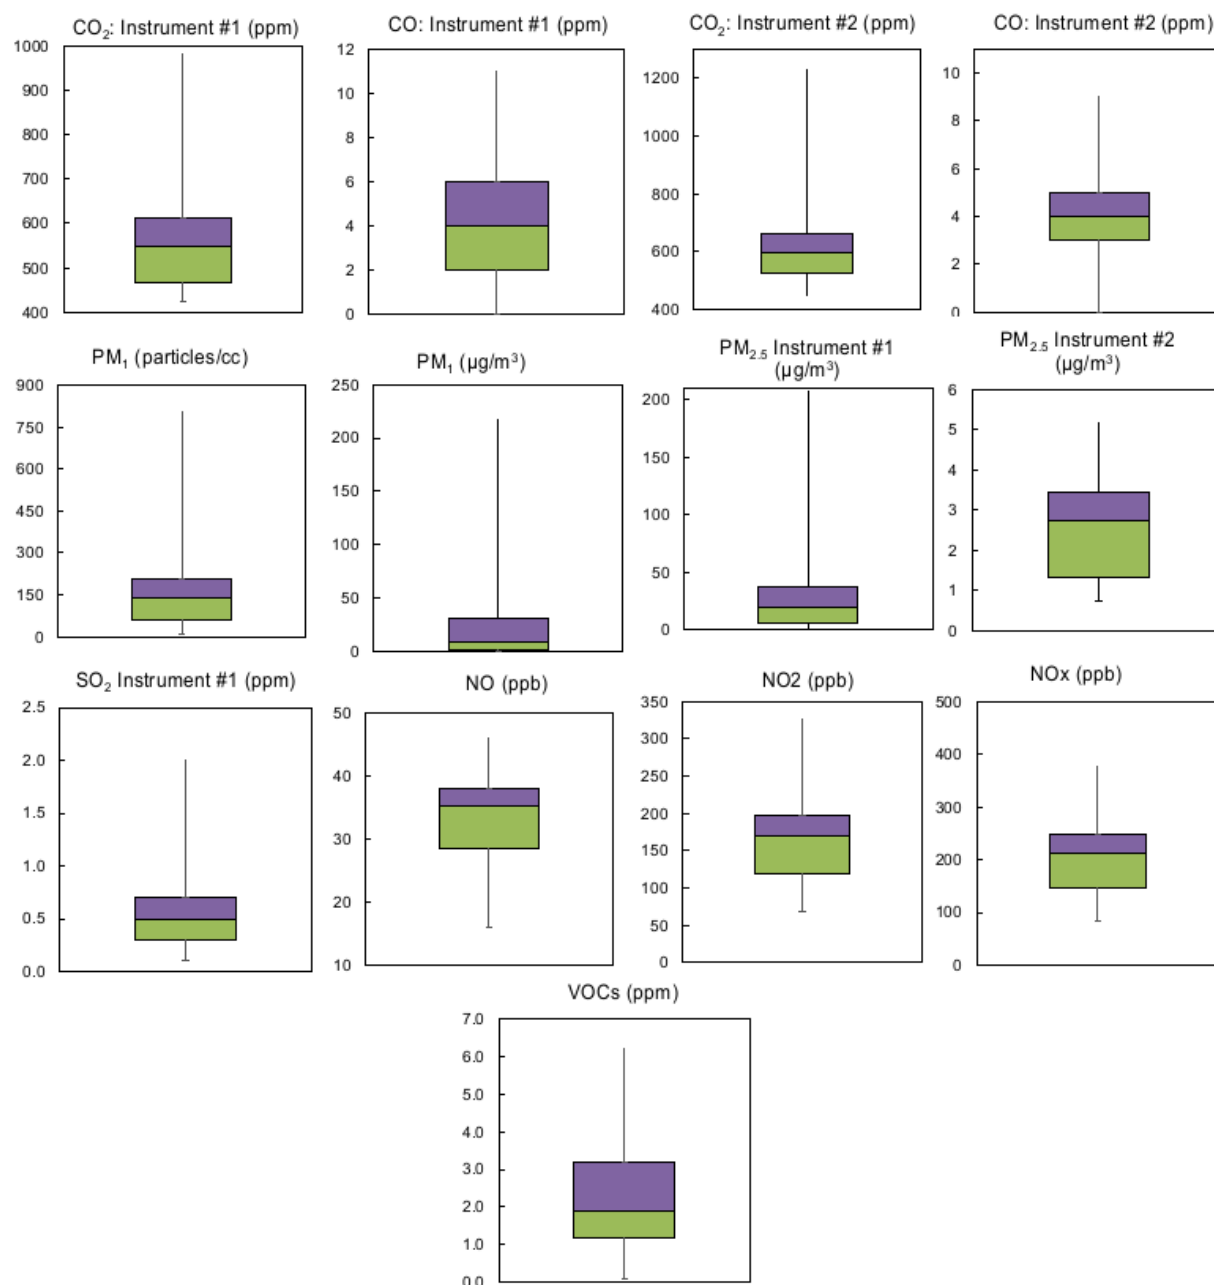
The data below shows ranges of air pollutants measured during the April 27th 2015 burn (Test-5). The data is presented in terms of box-plots showing the minimum, 25th percentile, 50th percentile (median), 75th percentile and maximum values; all measured during the burn duration.

Figure D-1: Air Quality During Tests

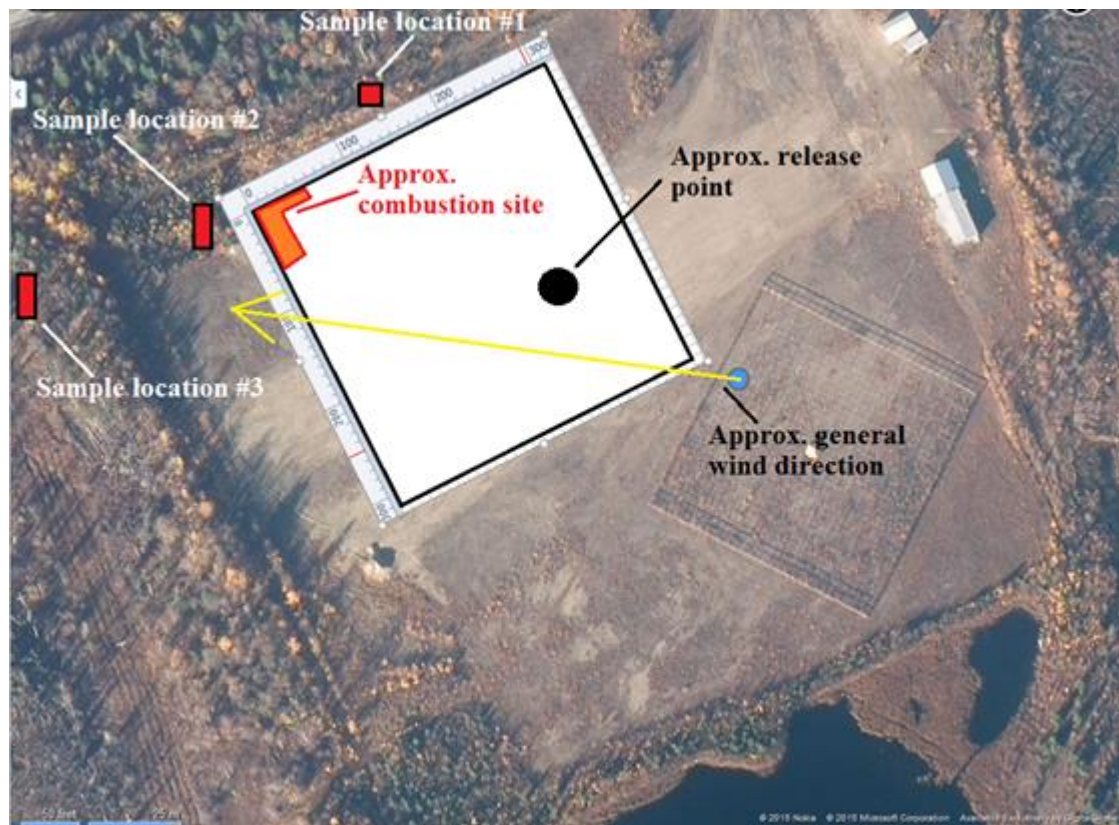
Figure D-2: Locations of Air Samplers

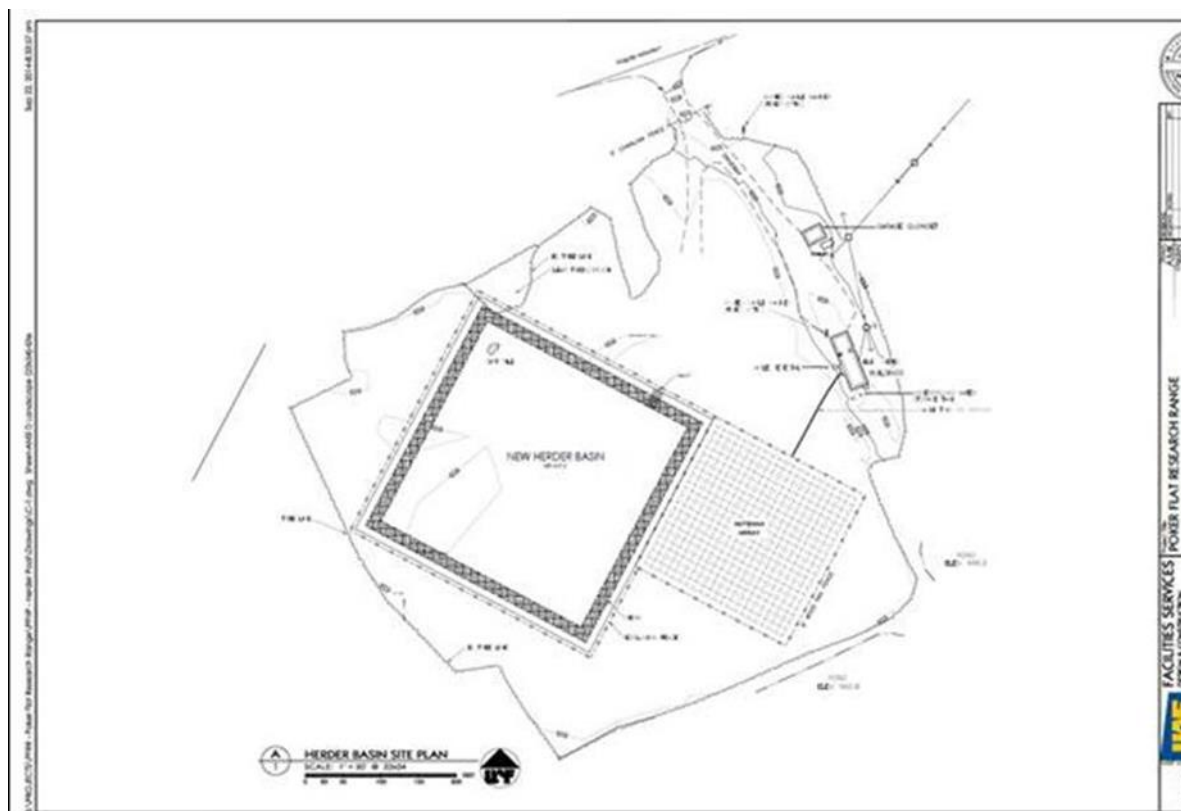
Figure E-3: Herder Test Basin Design and Site Layout

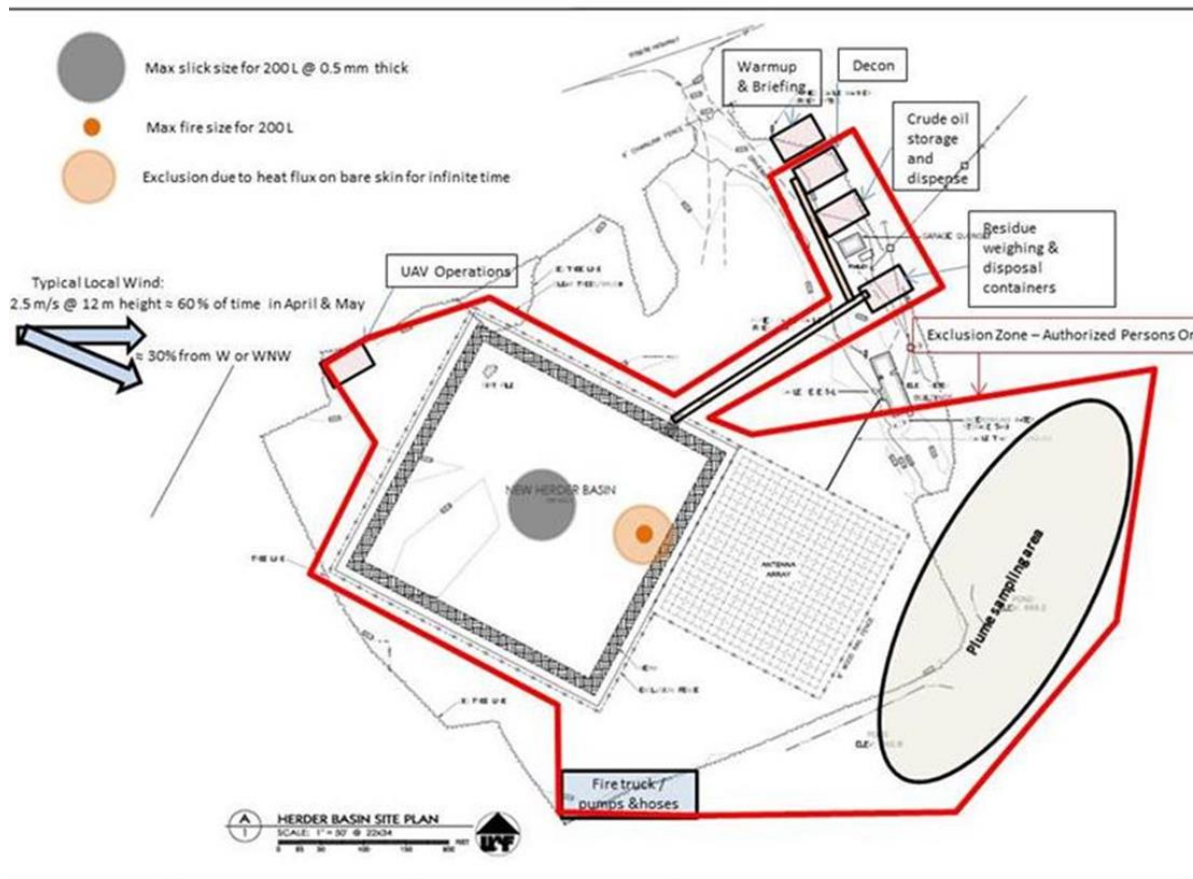
Figure E-11: Proposed Test Basin Layout

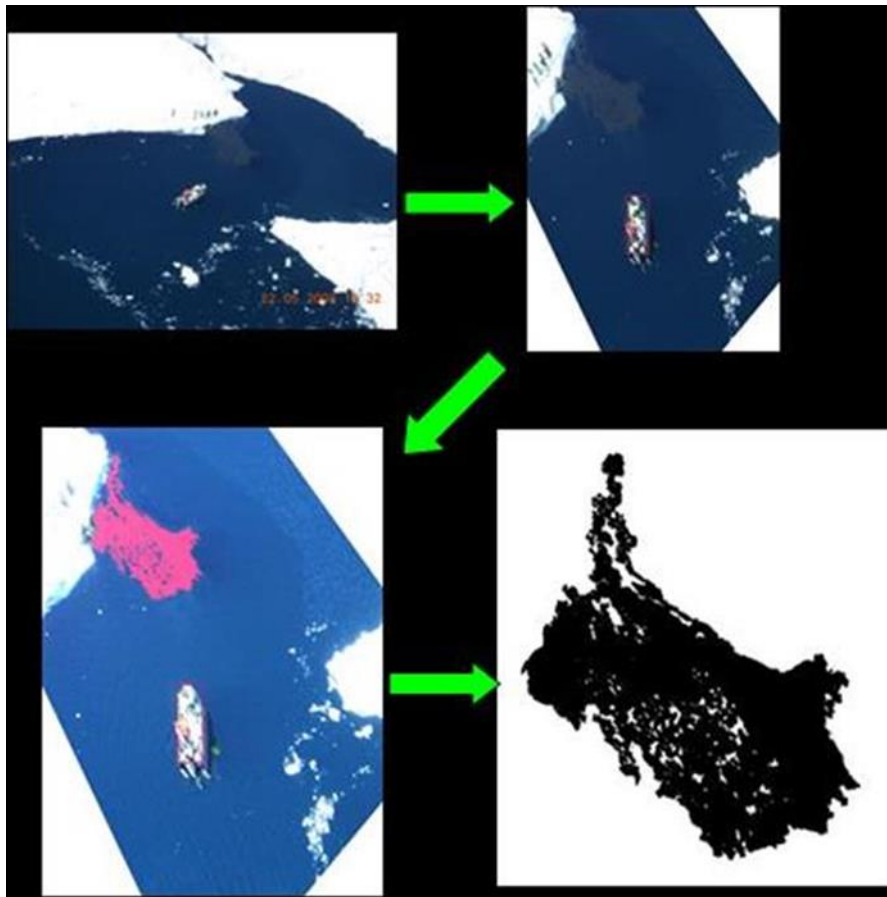
Figure E-12: Digital Transformation of Aerial Photographs to Determine Slick Area

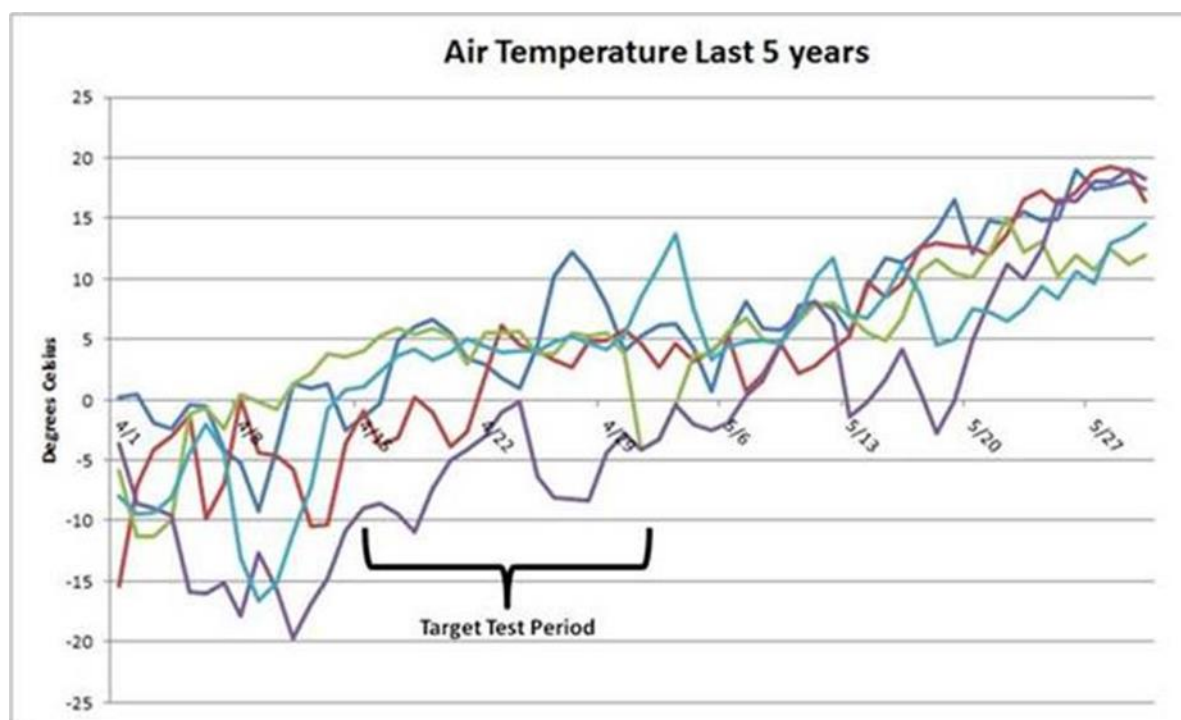
Figure E-13: Average daily temperature at test site over last five years – April 1 to May 31

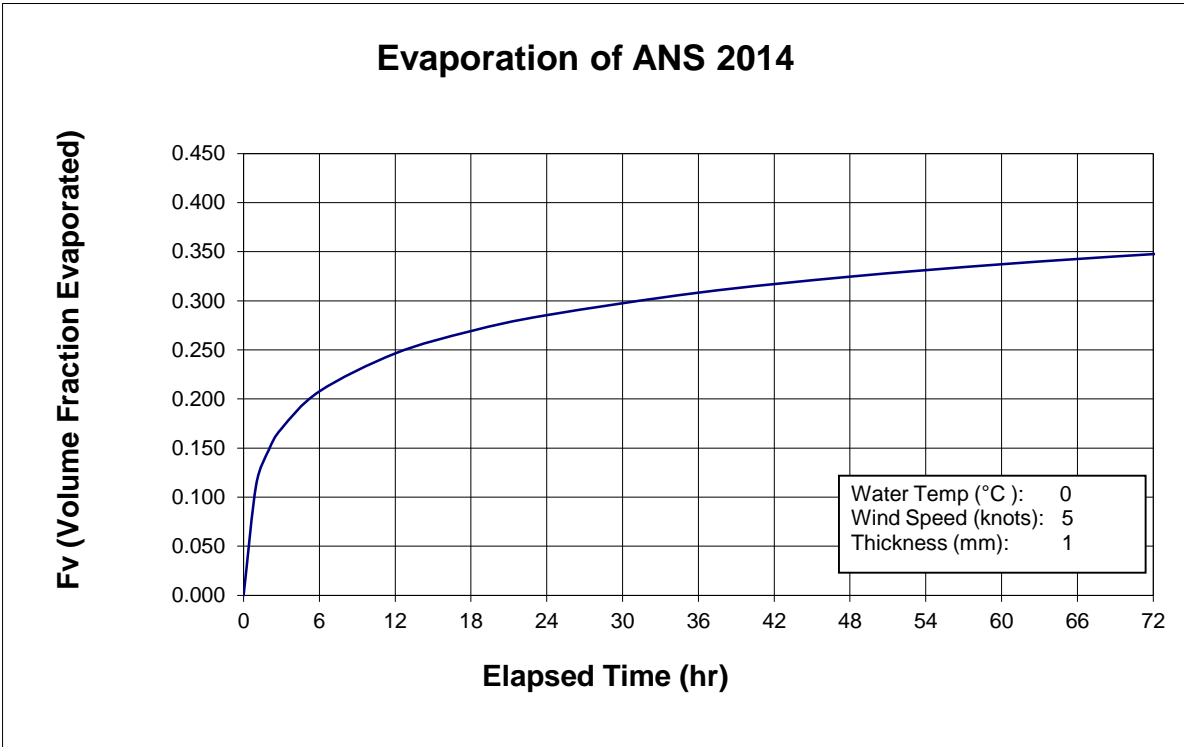
Figure G-1: Evaporation of ANS 2014

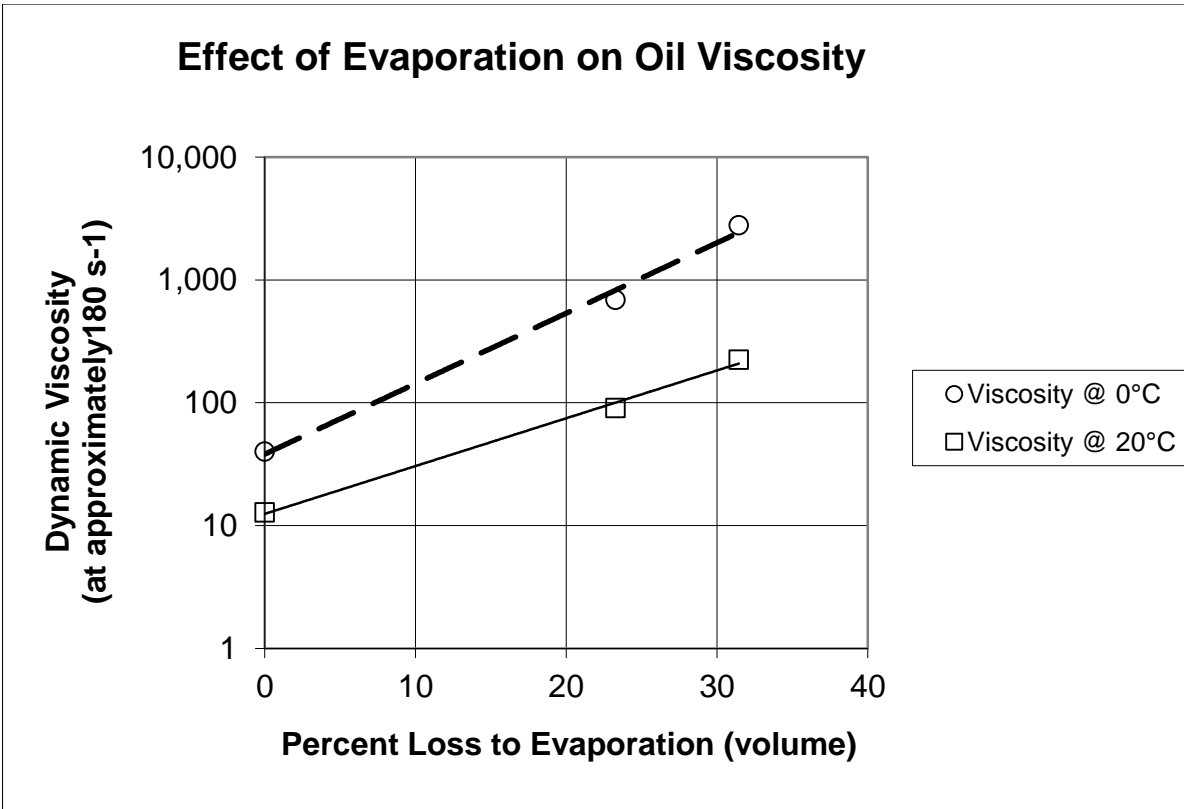
Figure G-2: Effect of Evaporation on Oil Viscosity

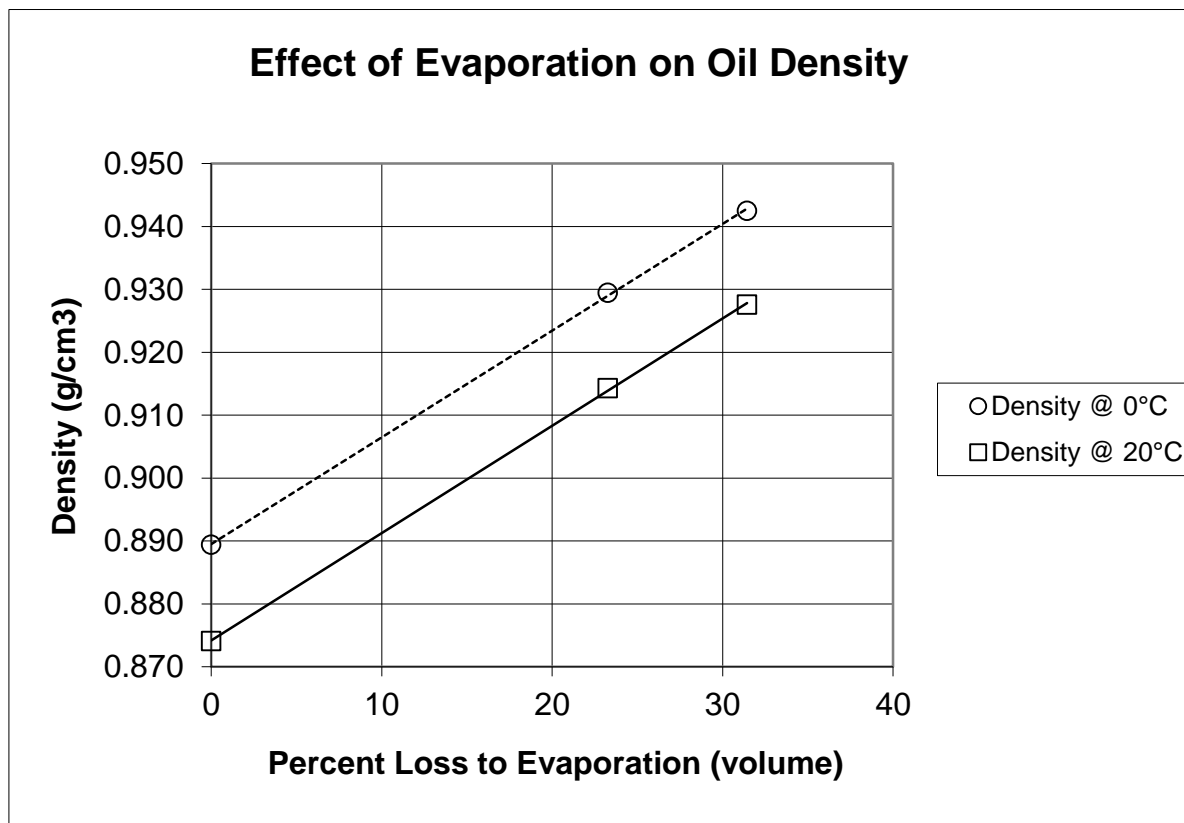
Figure G-3: Effect of Evaporation on Oil Density

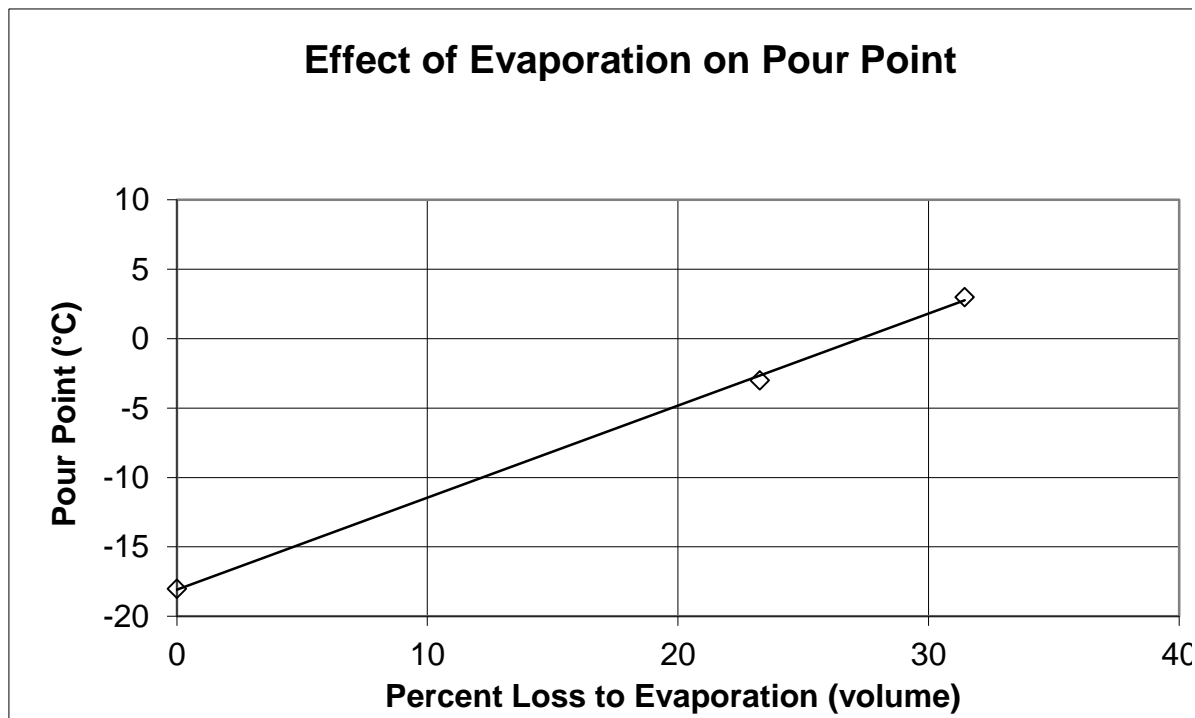
Figure G-4: Effect of Evaporation on Pour Point
